TOUCH FUNCTION UNRESPONSIVE

RESTRICTED MOTION

HOMING FAILURE

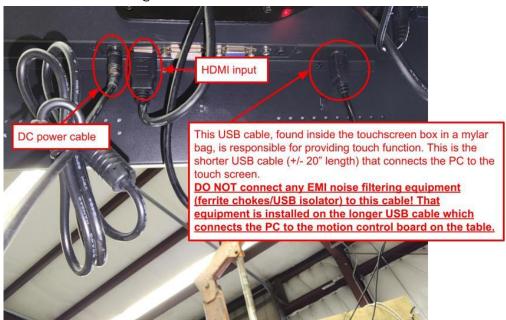
It is likely the short USB cable has not been connected to the touch screen. There should be 3 cables inserted at the bottom of the touch screen: 1. **Power** 2. **HDMI** 3. **12**" **USB** cable that came inside the white box with the touch screen. Please confirm all 3 cables are connected at the bottom of the touchscreen. If the issue persists, try a different USB slot on the MC4000 then call support between 715-130CST @9362353991.

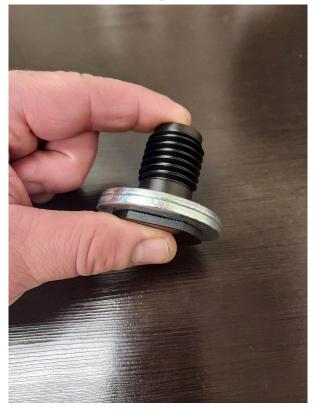
BALL SCREW TENSION X &Y

Another common issue is improperly tensioned ballscrews. To perform this simple check, grab a 3/16" hex key and position yourself at the tensioning end of the respective ball screw you are working on. All tensioning must be done from the positive ends of either axis (+Y, home position, +X, Y2 side) Make sure the gantry/carriage is positioned at least 6" from where you are working

to allow for adequate clearance. Insert the hex key into the 1" cap screw securing the ball screw with one hand and grasp the ball screw firmly with the other. Tension the screw a half turn. The ball screw in your hand should be getting tighter. If it is spinning in your hand there is an issue. Rotation means that the tensioning cap screw has bottomed out and can no longer add any tension to the system. Under these conditions you can expect there to be binding while jogging above 200IPM. To remedy this, an additional 1" washer is used to take up enough space so that the threaded cap screw can pull the ball screw tighter.

To do this, loosen the large hex nut securing the rod end bearing mount, then remove the 1" tensioning cap screw. Remove the rod end bearing mount and double up the 1" washer on the outside face. Then carefully reassemble the system and tension and align according to the assembly guide specifications. <u>https://youtu.be/rcFi07eejpo</u>

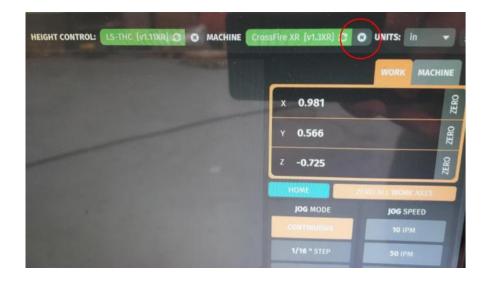
Check #1 Ballnut resistance inspection

Alignment issues will only be present near the ends of either axis. If you encounter binding outside of 12" from the travel limits on either axis alignment is not the issue.. Make sure the gantry is located on the side that needs alignment. Please see the alignment video for clarification. <u>https://youtu.be/rcFi07eejpo</u> After homing your machine to ensure the gantry is properly squared to the frame, disconnect from FC by clicking here,

then power off the enclosure. Making sure to disconnect before powering off will prevent the computer from rebooting. From the home position, jog in the negative Y-direction approximately 2-3" to allow adequate space to inspect. If there are no issues jogging on the X-axis use this system as your reference. With 2 fingers gently rotate the ballnut and observe the smoothness with which it spins. This is what the other axes should feel like. Inspect the remaining 2 ball nuts for any resistance in the system. If any is present make sure that your felt washers are not overly compressed and causing friction in the system. If the felts look good and resistance is present there is likely an alignment issue.Simply break loose the hex nut securing the rod end bearing mount and release the tension in the screw. Doing so will allow the system to realign the ball screw. Then simply re-tension and secure the hex nut.

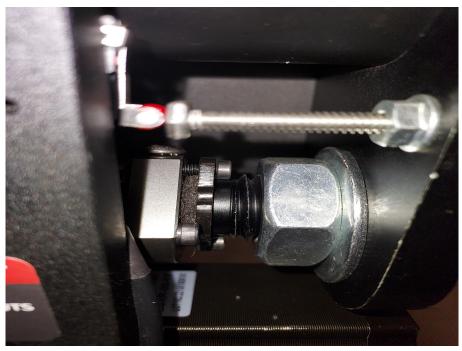
2. Improper limit switch stop position

The most likely scenario is that the limit switches are simply not set properly. To ensure that they are, jog the gantry to within a few inches of the home position, then power off the enclosure. Using a ³/₈" open-ended wrench, loosen to jam nut securing the limit switch stop and back it out approximately half an inch(away from engaging the limit switch). Then position yourself in the center of the gantry at the rear of the machine and pull evenly across the beam until both ballnuts on the Y-axis are seated against the black aluminum rod end bearing mounts as shown.

Confirm both sides are contacting to ensure the gantry is square to the frame. Next, extend the limit switch stops towards the limit switch. Continue extending until the switch clicks, then continue extending just slightly further until there is approximately 1/32" between the metal arm of the switch and the plastic body of the switch. This will ensure that the limit switch will engage fully before reaching its travel limit while also guaranteeing that there can never be overtravel which could result in the damaging of the switch. Rehome the machine. If trouble persists, continue on.

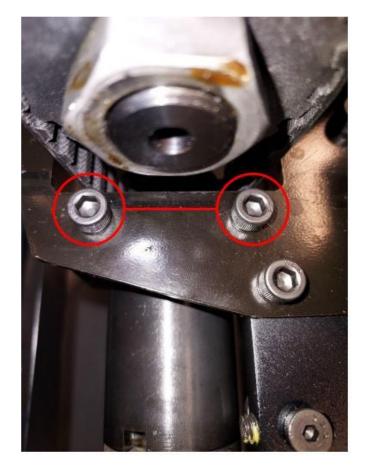
X - AXIS BINDING

This condition isn't generally the result of issues with the assembly process. In most instances there is minor misalignment in the X-axis ballnut hub that can be resolved very simply. Start by jogging your X/Z carriage to the Y2 side of the table at whatever speed can be managed so it can be easily reached and worked on. Locate the 2 cap screws securing the ballnut hub below.

The screws are located directly underneath the X-motor pulley where the belt goes through the mount. Using a 3/16" allen key, crack and leave both cap screws 1 full turn loose. Next, jog the carriage towards the Y1 side 18-24". Set your jog speed back to 400IPM and function test the motion. If the issue is resolved simply hand tighten the cap screws. The hub will be secured by the tension in the ballscrew as well so there is no risk of it coming loose. If the problem persists proceed to the following step.

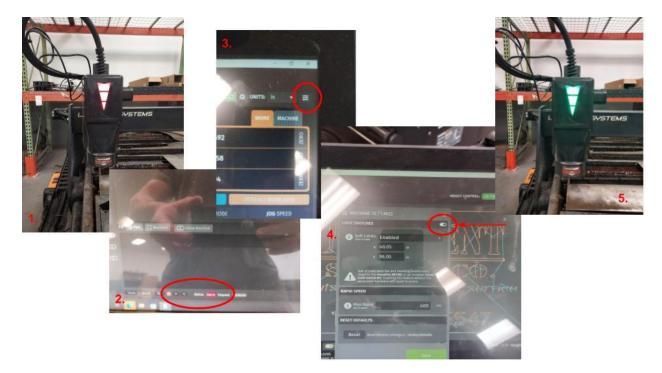
HARD LIMIT TRIGGERED

In the event a hard limit is triggered and the gantry is locked out and immobilized there is a simple solution that does not require it to be moved off the limit switch manually. Simply open up

the machine settings menu, toggle off the limits temporarily and hit save. Clear the machine from the limit switch by jogging either in the +X or -Y direction. If you're uncertain about which switch has been triggered you can see which alarm has been thrown at the bottom of the screen in FireControl. The triggered switch will be illuminated red in the alarm section at the bottom of the screen.

Once the alarm has been cleared reopen the menu and toggle the limits back on and save. You will notice by default your soft limits are disabled when you turn off the limits. With them disabled your table display will be removed from the visualizer. Soft limits provide a visual display of your position on your table and are helpful when loading a program. They will also prevent your torch from attempting to move outside the travel limits. You will want to re-enable them in the same menu by clicking "enable" from the drop down menu. You cannot toggle on the limits and re-enable soft limits at the same time. The limits must be toggled on and saved before the soft limits can be enabled. It is wise to rehome your machine after performing this procedure to ensure global positional accuracy (Machine Coordinates).

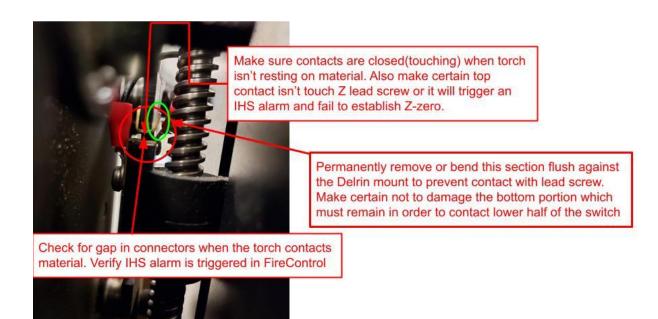
IHS FAIL(Non-Zero resting THC voltage/ Failure to establish Z-Zero/ Torch not contacting material)

If FireControl is unable to establish Z-zero due to an IHS fail it is likely that the IHS switch has been compromised and needs corrective action. This can happen if the Z axis is accidentally maxed out in the +Z direction. When this occurs the upper IHS contact can snag between the motor shaft coupler that connects the Z lead screw and is often bent towards the lead screw. If the switch makes contact with the screw it will ground and register in FC as an open circuit preventing FireControl from establishing Z-zero. It can also cause the THC to read a non-zero voltage while at rest or trigger a misfire warning alarm in FC due to a perceived voltage spike.

Because of how voltage is interpreted by FireControl, even a minute extraneous voltage input from the 5V switch leaching into the frame will cause a massive spike.

To permanently correct this, use tin snips or a sharp pair of metal-cutting scissors to nip off the tab that is bent towards the screw. Make certain not to damage the bottom portion of the brass tab which needs to make contact with the lower half of the switch in order to function. If you are unable to remove the tab, you can use two flat-blade screwdrivers to bend the tab back flush against the black Delrin mount it is attached to, parallel with the torch slide and away from the lead screw.
