## TECHNICAL BULLETIN - 9/23/2020

It has come to our attention that some Razorcut 45 Plasma Cutters may have been affected by an infrequent misfiring issue. During investigation, it has been determined that this issue is caused by improper timing delay between the electrode start current and the air solenoid valve. Fortunately, a field repair using off-the-shelf supplies can be easily performed to fix the issue.

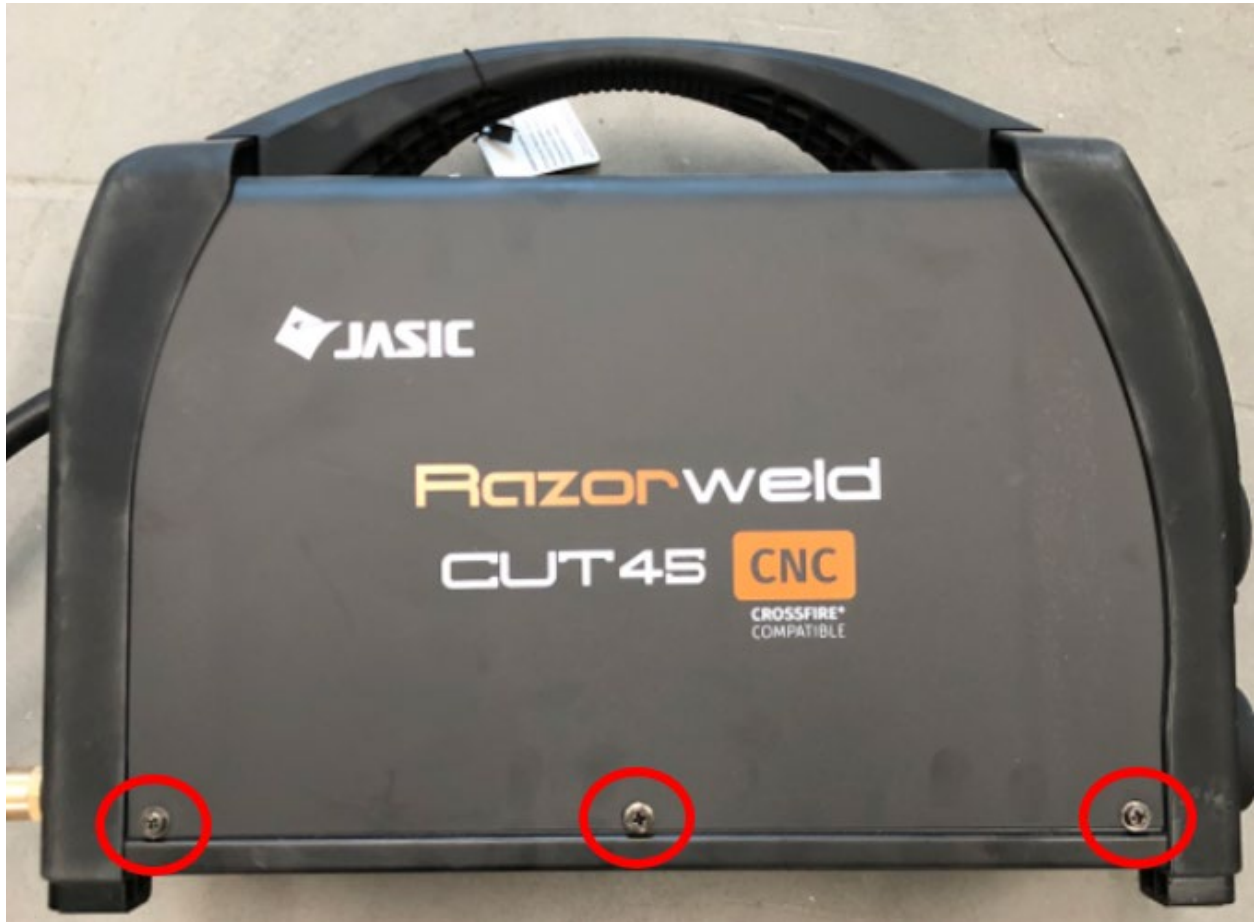
- 2.) Remove the 3 sheet metal screws from one side of the plasma cutter. Flip the cutter over and remove the 3 additional sheet metal screws on the opposite side of the plasma cutter. The fastener locations for one side are shown circled in red below.

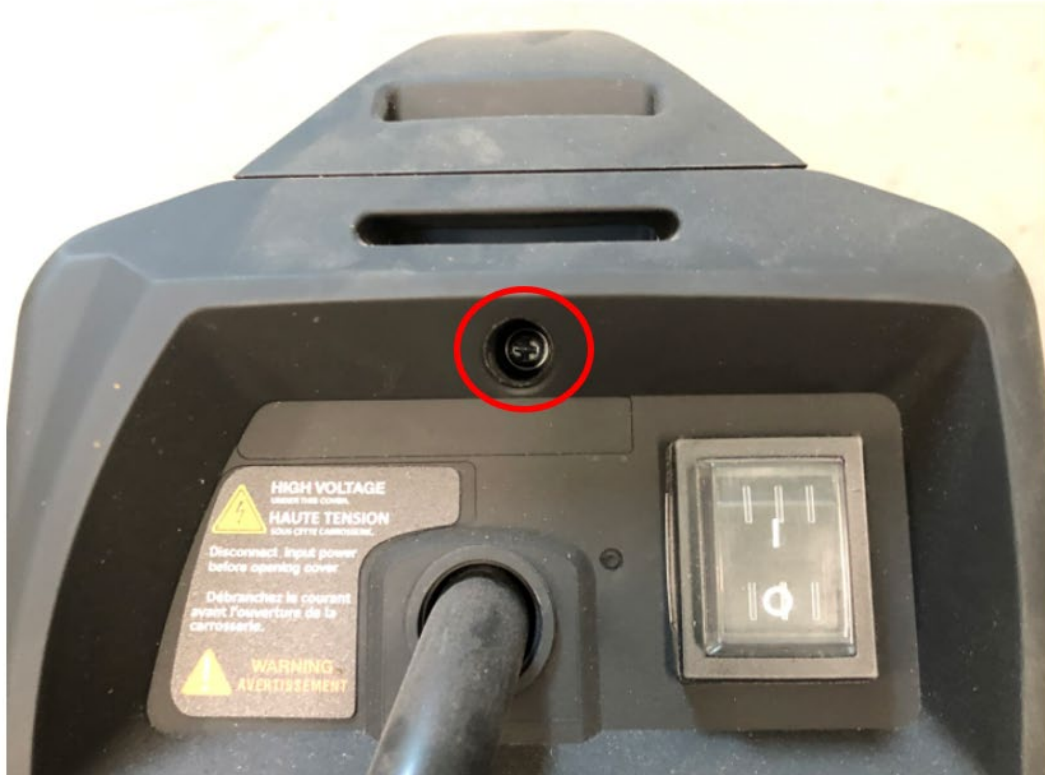
3.) Remove the 1 screw on the back of the plasma cutter as shown in the picture below circled in red.

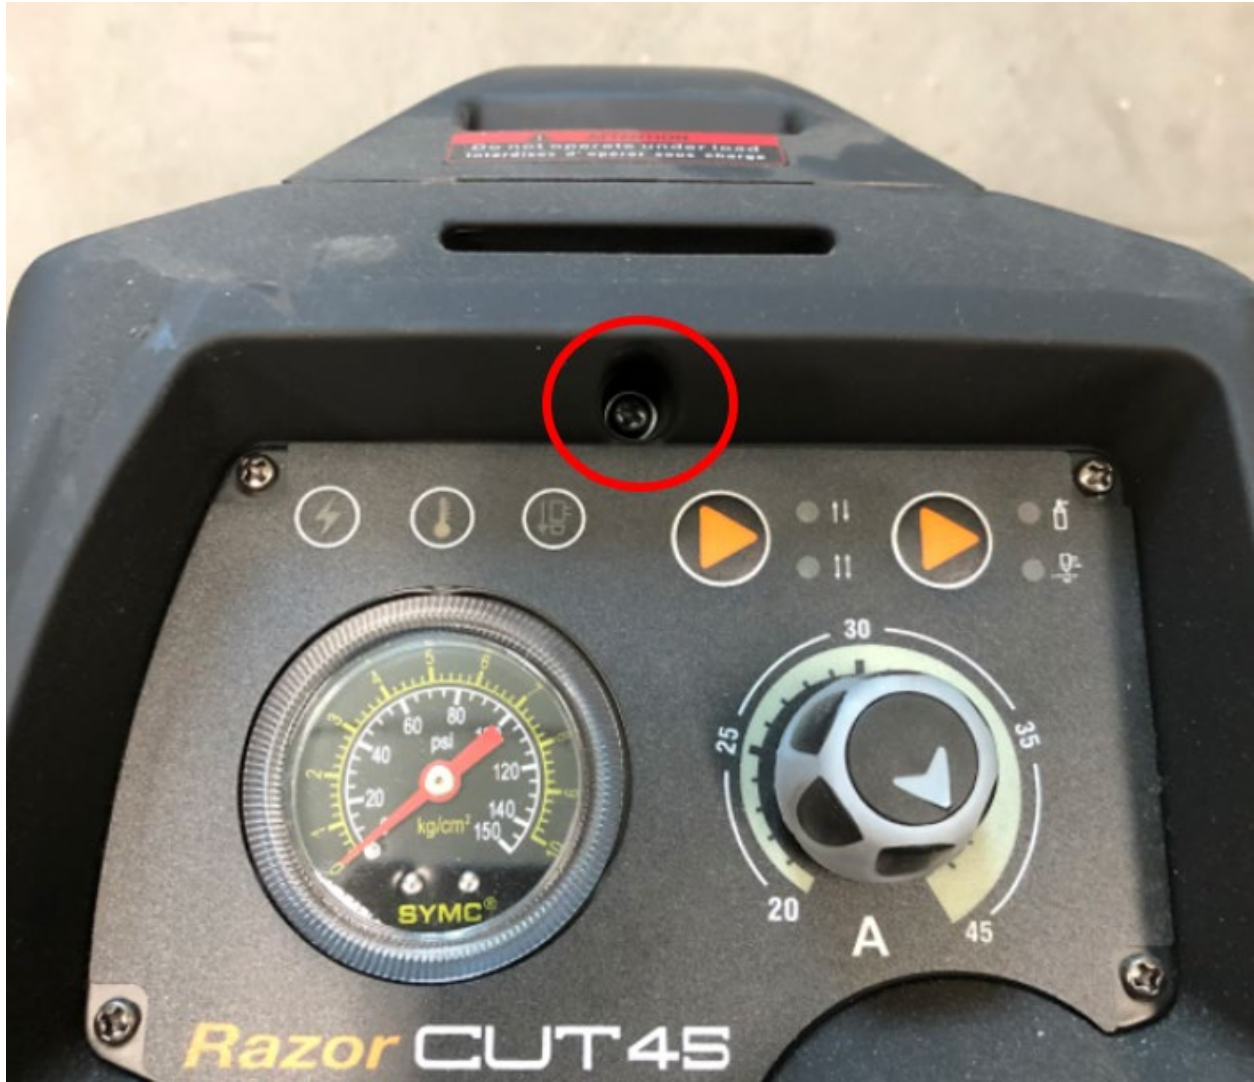
- 4.) Remove the 1 screw on the front of the plasma cutter as shown in the picture below circled in red.

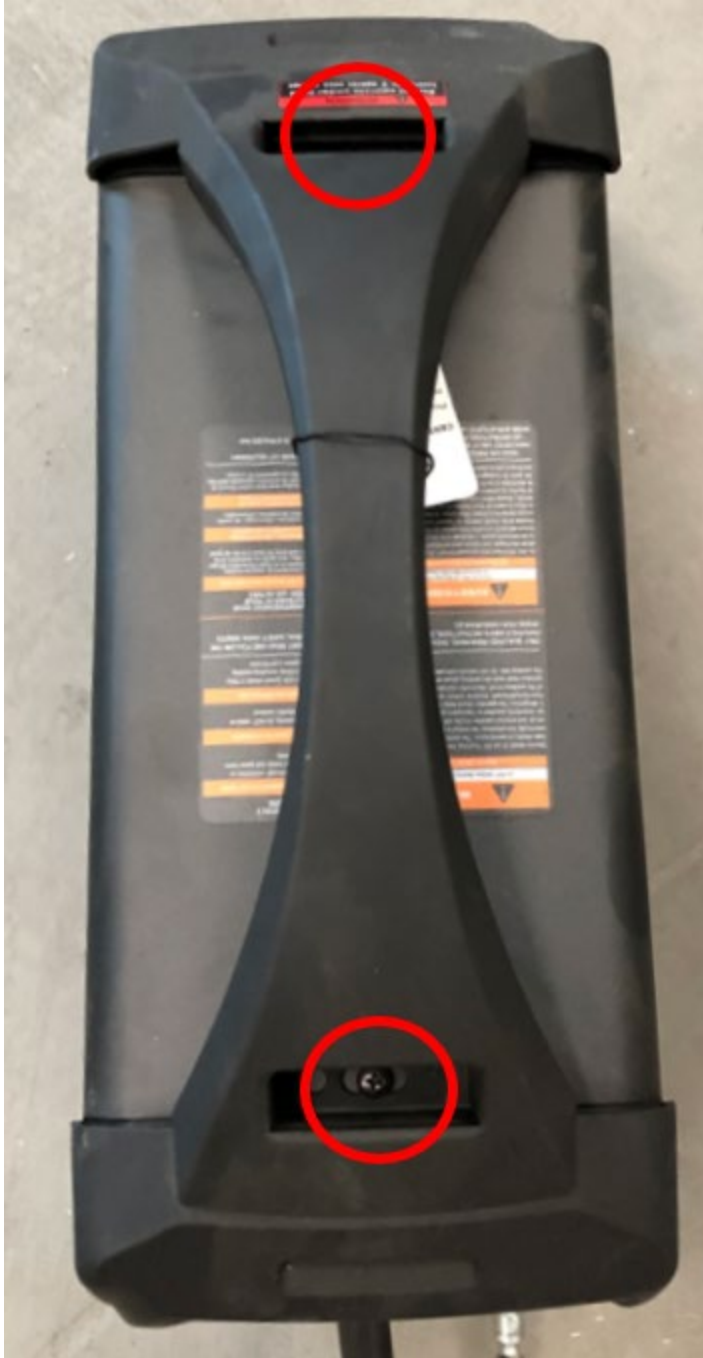
- 5.) Remove the 2 screws from the top of the plasma cutter as shown in the picture below circled in red.

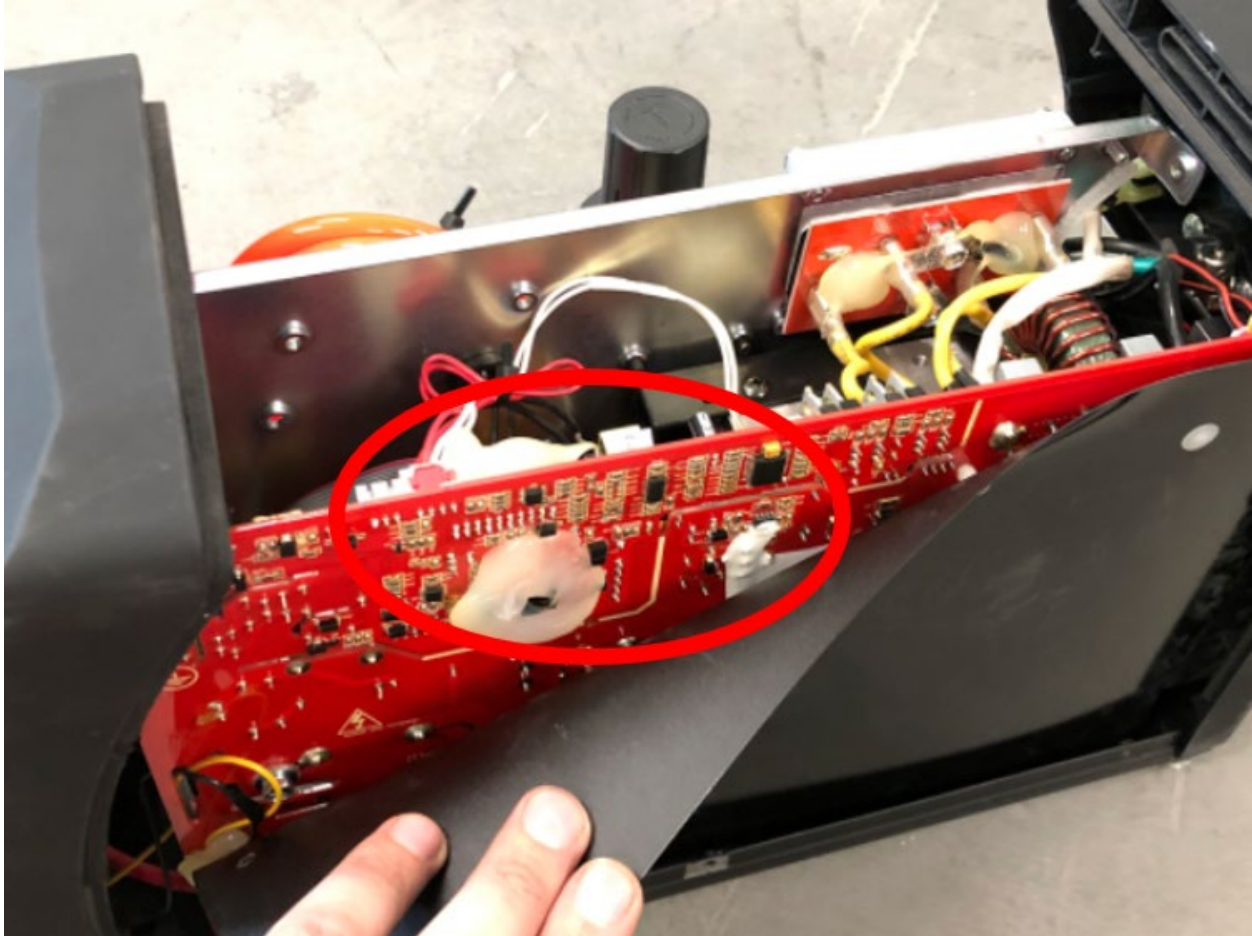
8.) Inside the plasma cutter you will find the large red control board. On the backside of this is a black plastic panel; peel back this plastic panel to reveal the area that we will be working on for the repair. Below is an image of the exposed area of interest circled in red.

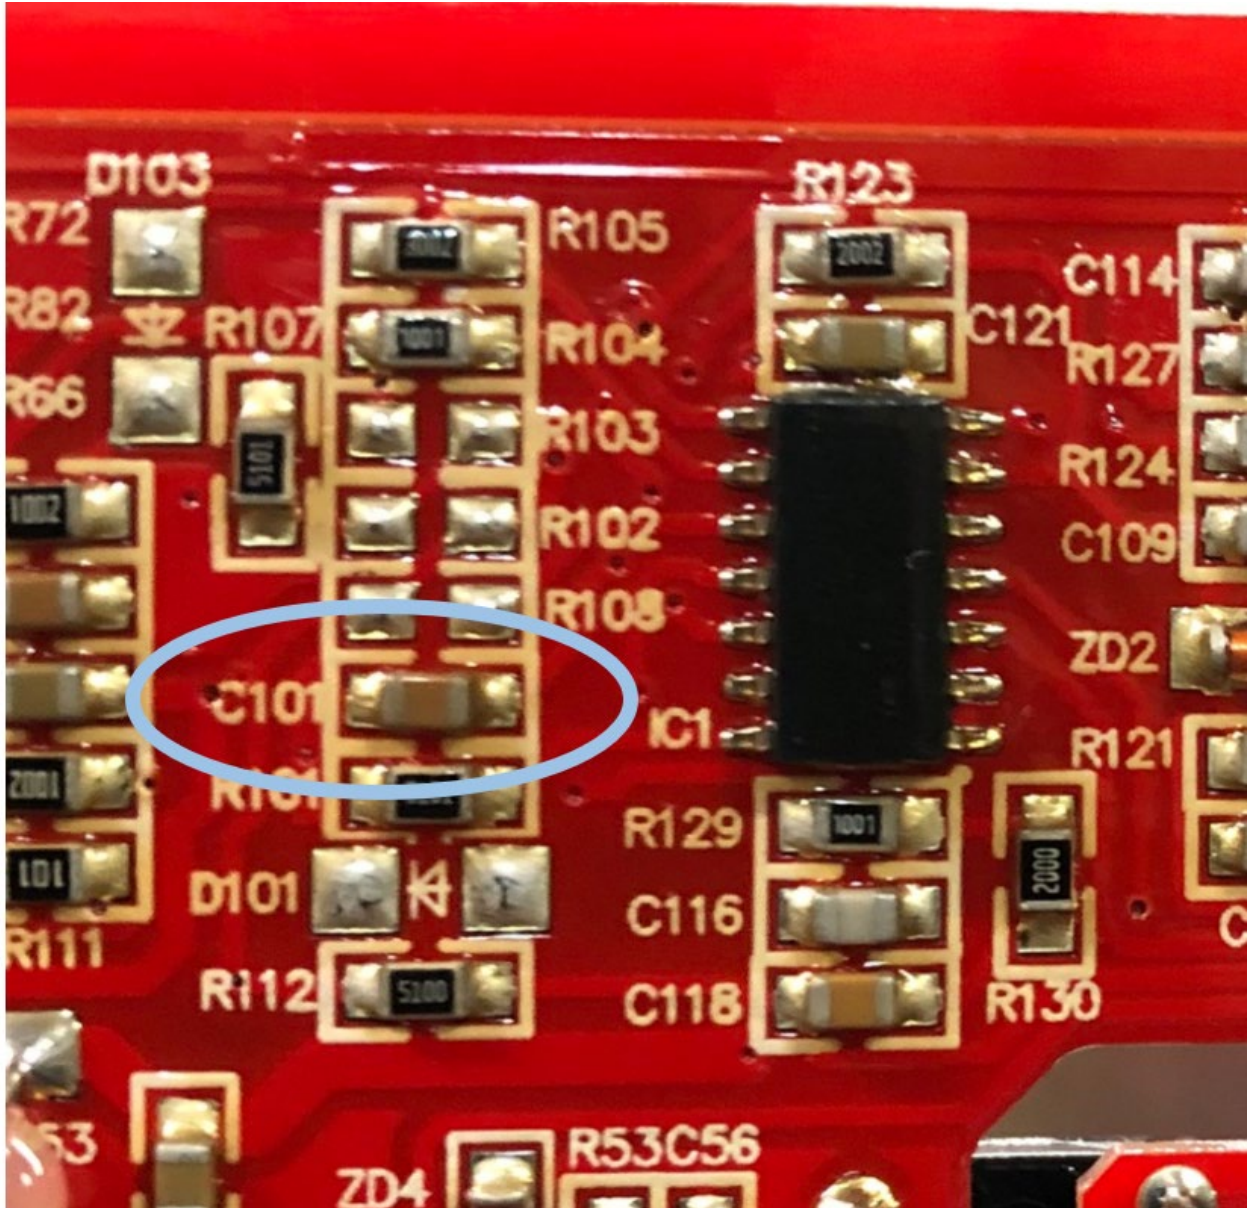
- 9.) Next, locate the capacitor labeled C101 on the red board. It is circled in blue below.  
NOTE: IF YOU CANNOT LOCATE THE C101 CAPACITOR, IT IS POSSIBLE THAT IT IS UNDER A GLOB OF WHITE RTV SILICONE. PEEL THIS SILICONE OFF THE RED BOARD TO EXPOSE THE REGION IN QUESTION BEFORE CONTINUING.

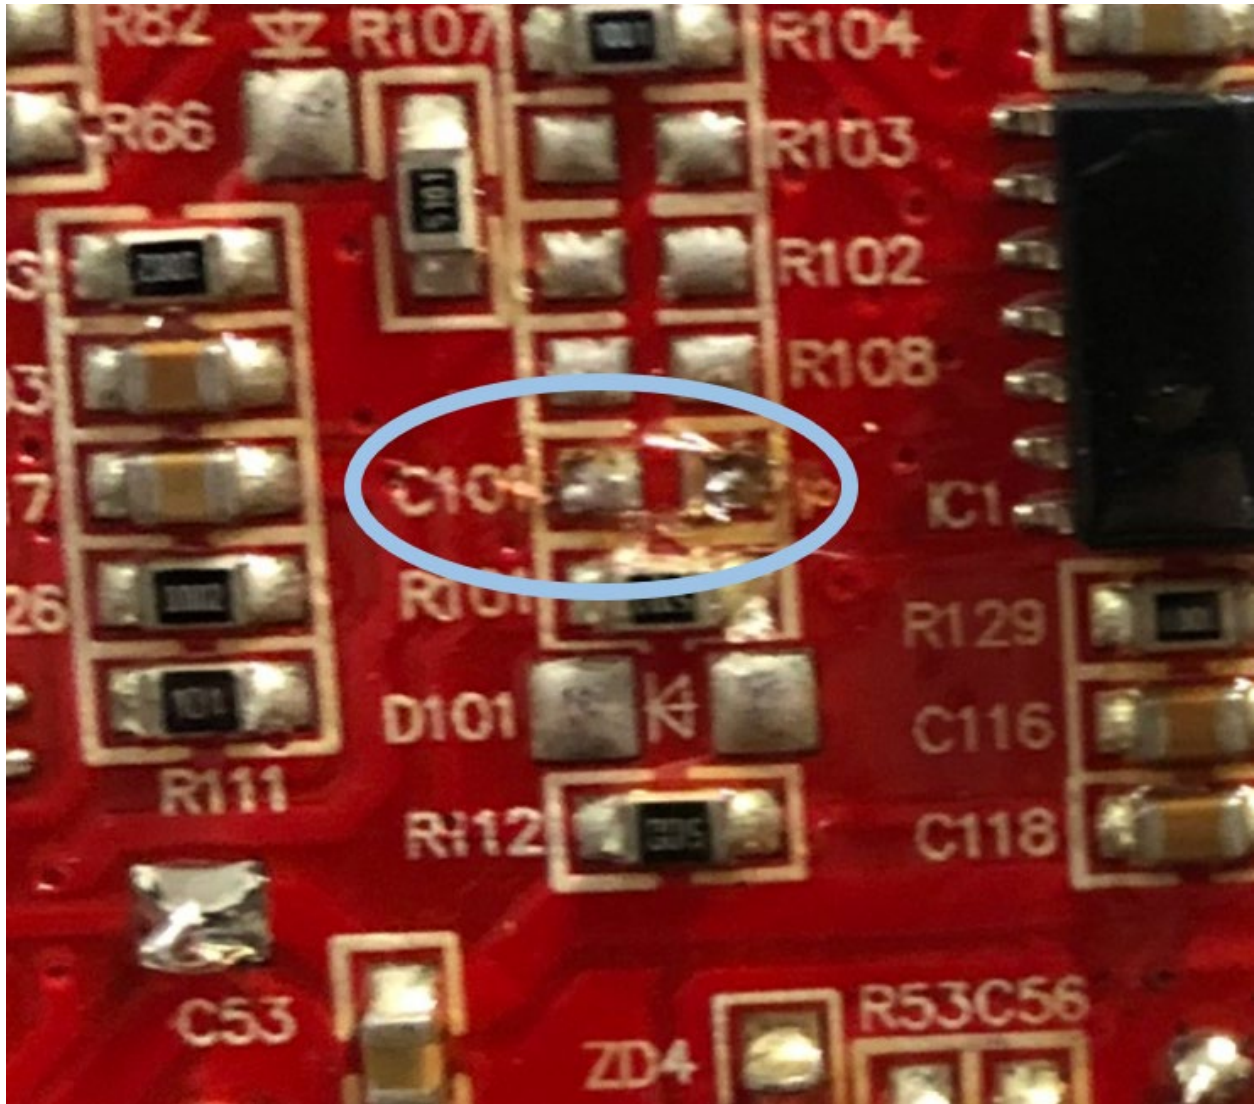
- 10.) Next, you will need to remove this C101 capacitor from the board completely. The easiest way to do this is to touch your hot solder tip against the solder pad on the left side of the capacitor until the solder turns liquid. Once this happens, flick your soldering iron to the right to peel this capacitor up and off the left side pad. Once the resistor has been peeled, you may need to use your soldering iron on the right pad to remove the capacitor completely. You can discard this capacitor; we will be keeping these solder pads empty. If performed correctly, your board should look like the picture below. **NOTE: BE CAREFUL TO AVOID ACCIDENTALLY REMOVING ANY ADJACENT COMPONENTS HERE. ALSO BE CERTAIN THAT THE SOLDER PADS FOR C101 REMAIN EMPTY AND DO NOT TOUCH ADJACENT PADS WITH SOLDER WHEN REMOVED.**

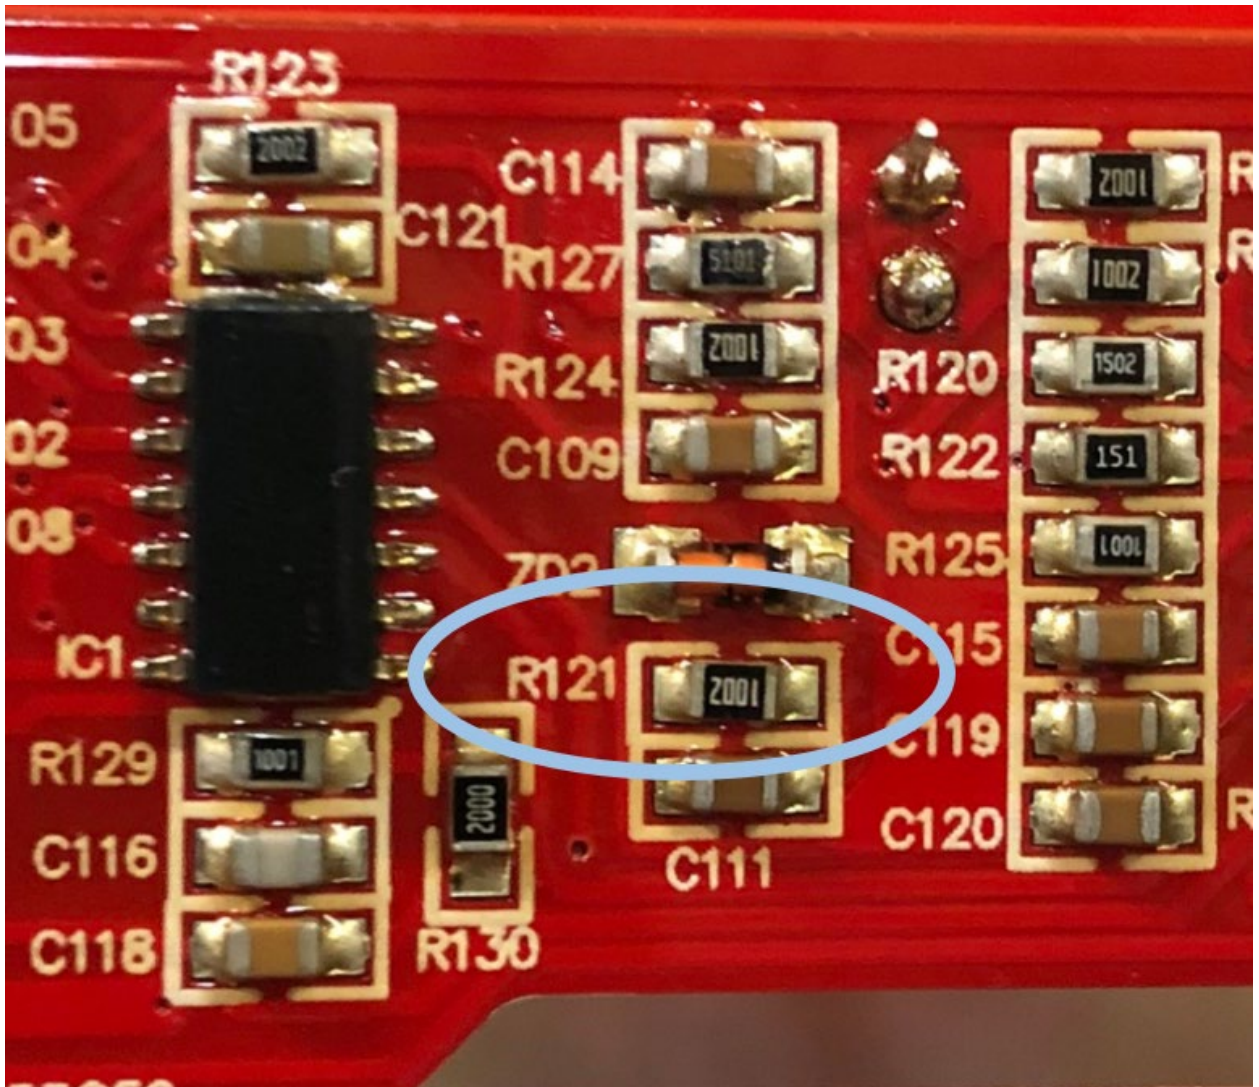
- 11.) Next, you will be removing the R121 resistor from the board completely and replacing it with a 100k $\Omega$  resistor. The R121 resistor is shown circled below in blue. NOTE: IF YOU CANNOT LOCATE THE C101 CAPACITOR, IT IS POSSIBLE THAT IT IS UNDER THE WHITE RTV SILICONE. PEEL THIS SILICONE GLUE OFF THE RED BOARD TO EXPOSE THE REGION IN QUESTION BEFORE CONTINUING.

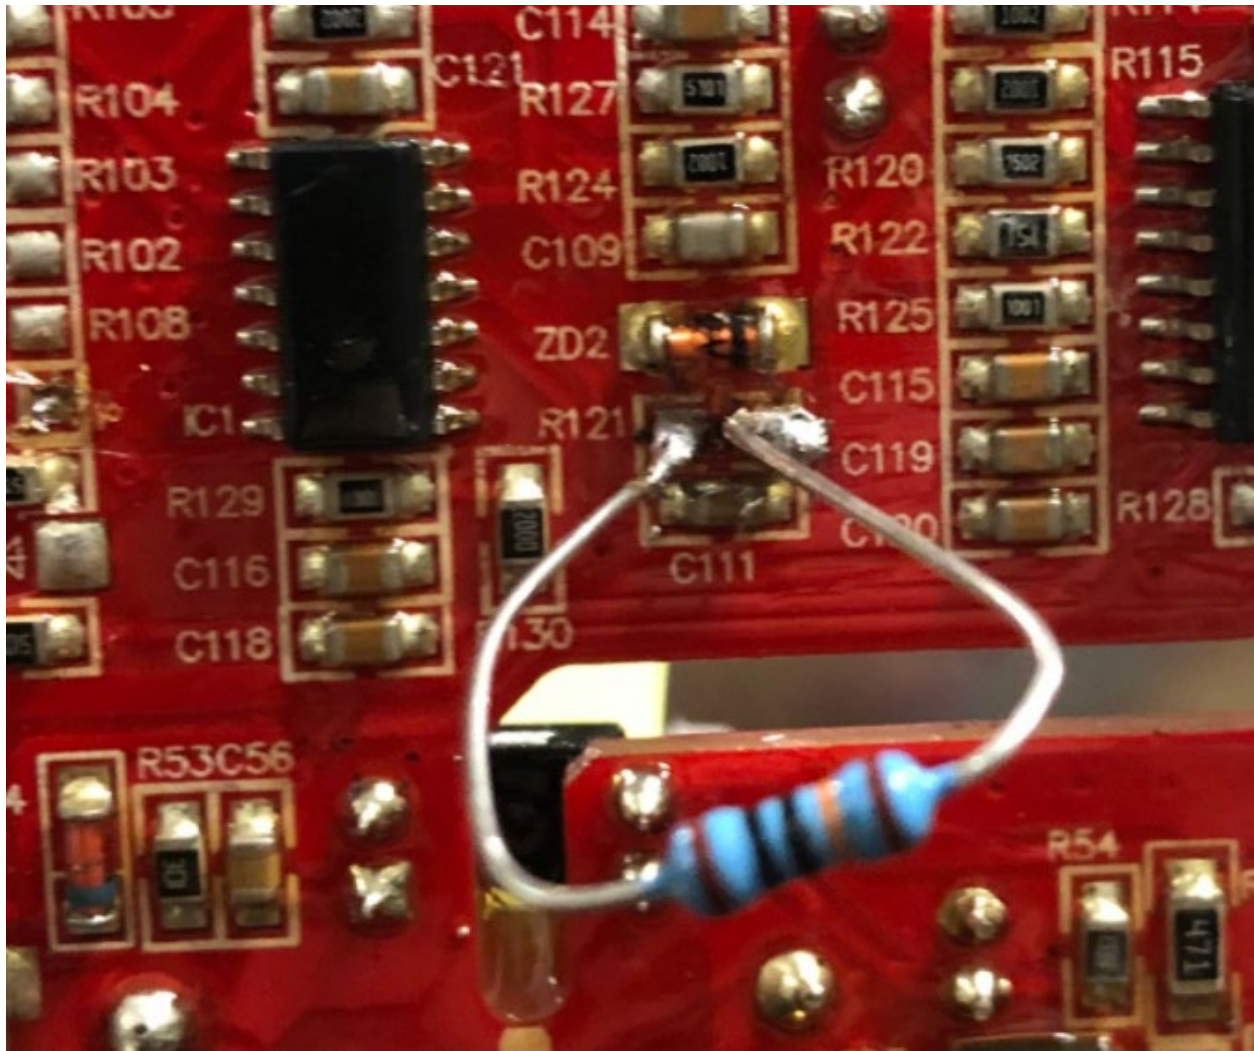
- 12.) To do this we first need to remove the R121 resistor from the board. You will do this in the exact same manner that was used to remove the C101 capacitor above. After removing this resistor, you will need to solder the 100k $\Omega$  resistor to the two empty solder pads at the R121 position. Solder one end of the resistor to one of the solder pads and solder the other end of the resistor to the remaining solder pad. When done correctly, your soldered resistor should look like the picture shown below. NOTE: BE CERTAIN THAT AFTER SOLDERING THE RESISTOR INTO POSITION, YOUR NEW SOLDER JOINT DOES NOT TOUCH THE ADJACENT SOLDER PADS FOR ZD2 AND C111. IF YOU ARE UNCERTAIN, USE A MULTIMETER TO VERIFY THERE IS NO CONTINUITY BETWEEN ADJACENT SOLDER PADS.

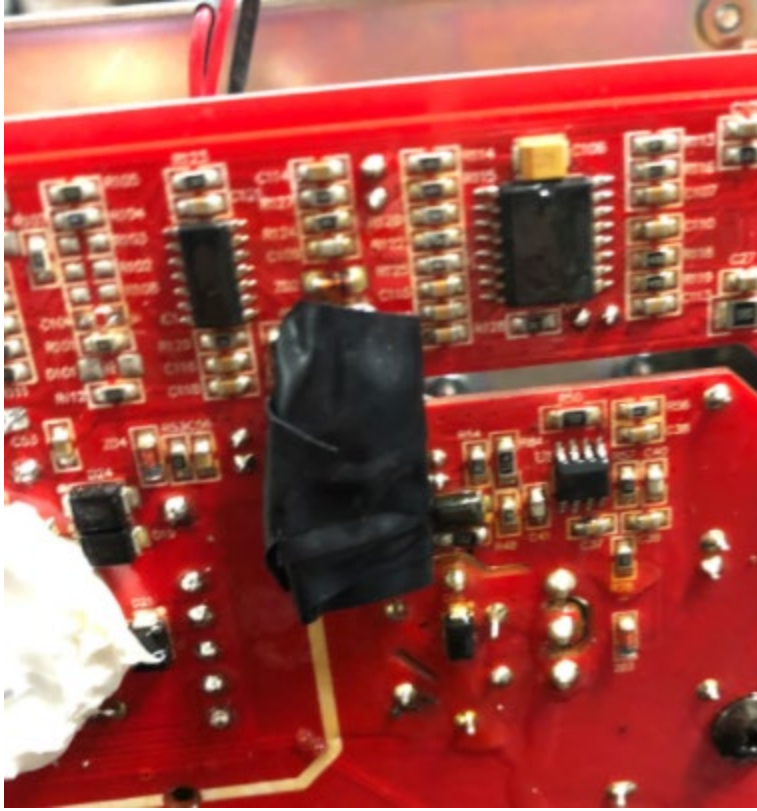
- 13.) After completing the solder repair, you will need to wrap the exposed resistor leads in electrical tape or shrink wrap to prevent these leads from touching other components on the board. After completely wrapping the solder leads, fold the resistor down as shown below. Be certain to visually inspect that the resistor is not touching any other components at the base when folded down into position.
