TOUCH FUNCTION UNRESPONSIVE

NO SUPPORT FOR OPEN GL. 3.0/NO VISUALIZER DISPLAY/GRAPHICS DRIVER ISSUE

HOME BUTTON MISSING/CUTTING ENVELOPE NOT DISPLAYED IN VISUALIZER

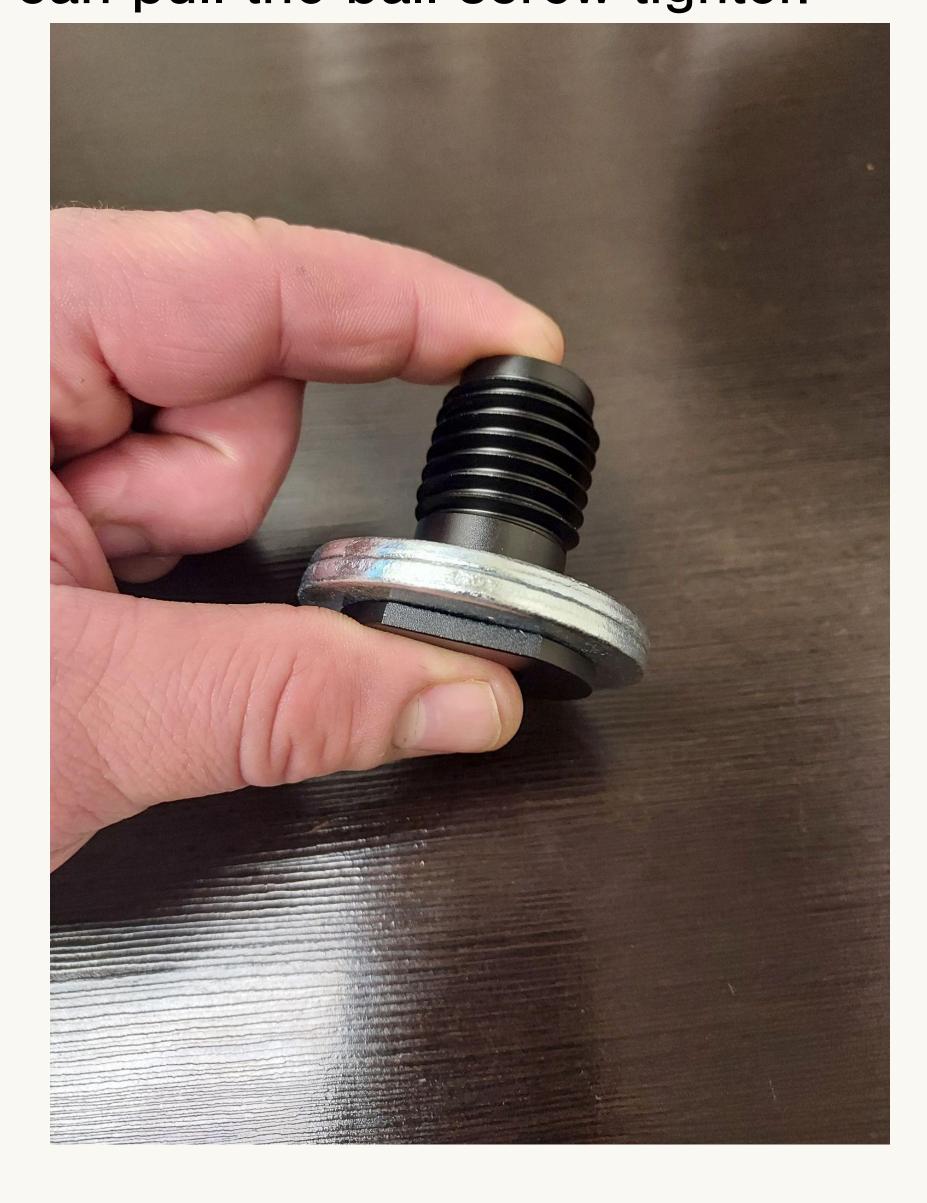
Another common issue is improperly tensioned ballscrews. To perform this simple check, grab a 3/16" hex key and position yourself at the tensioning end of the respective ball screw you are working on. All tensioning must be done from the positive ends of either axis (+Y, home position, +X, Y2 side) Make sure the gantry/carriage is positioned at least 6" from where you are working to allow for adequate clearance. Insert the hex key into the 1" cap screw securing the ball screw with one hand and grasp the ball screw firmly with the other. Tension the screw a half turn. The ball screw in your hand should be getting tighter. If it is spinning in your hand there is an issue. Rotation means that the tensioning cap screw has bottomed out and can no longer add any tension to the system. Under these conditions you can expect there to be binding while jogging above 200IPM. To remedy this, an additional 1" washer is used to take up enough space so that the threaded cap screw can pull the ball screw tighter.

To do this, loosen the large hex nut securing the rod end bearing mount, then remove the 1" tensioning cap screw. Remove the rod end bearing mount and double up the 1" washer on the outside face. Then carefully reassemble the system and tension and align according to the assembly guide specifications. https://youtu.be/rcFi07eejpo

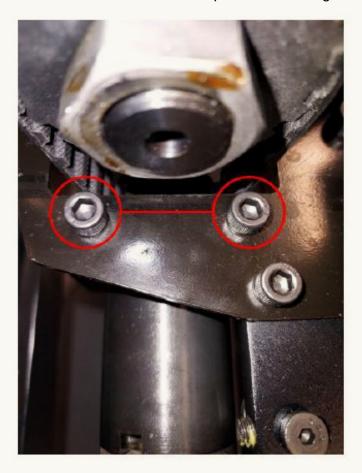
This condition isn't generally the result of issues with the assembly process. In most instances there is minor misalignment in the X-axis ballnut hub that can be resolved very simply. Start by jogging your X/Z carriage to the Y2 side of the table at whatever speed can be managed so it can be easily reached and worked on. Locate the 2 cap screws securing the ballnut hub below.

The screws are located directly underneath the X-motor pulley where the belt goes through the mount. Using a 3/16" allen key, crack and leave both cap screws 1 full turn loose. Next, jog the carriage towards the Y1 side 18-24". Set your jog speed back to 400IPM and function test the motion. If the issue is resolved simply hand tighten the cap screws. The hub will be secured by the tension in the ballscrew as well so there is no risk of it coming loose. If the problem persists proceed to the following step.

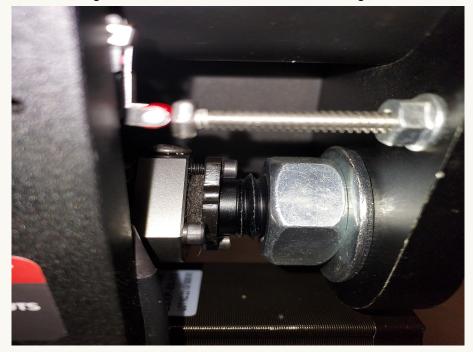
approximately half an inch(away from engaging the limit switch). Then position yourself in the center of the gantry at the rear of the machine and pull evenly across the beam until both ballnuts on the Y-axis are seated against the black aluminum rod end bearing mounts as shown.

Confirm both sides are contacting to ensure the gantry is square to the frame. Next, extend the limit switch stops towards the limit switch. Continue extending until the switch clicks, then continue extending just slightly further until there is approximately 1/32" between the metal arm of the switch and the plastic body of the switch. This will ensure that the limit switch will engage fully before reaching its travel limit while also guaranteeing that there can never be overtravel which could result in the damaging of the switch. Rehome the machine. If trouble persists, continue on.

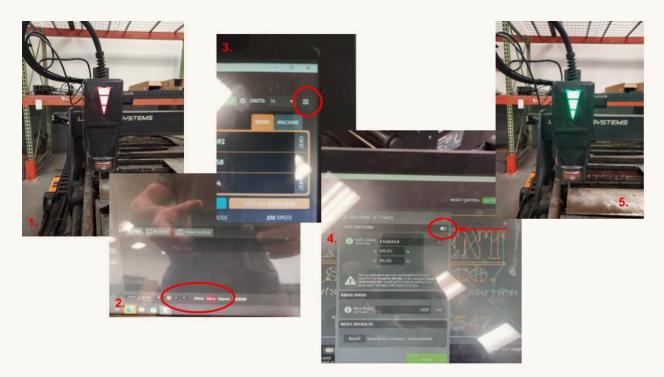
In the event a hard limit is triggered and the gantry is locked out and immobilized there is a simple solution that does not require it to be moved off the limit switch manually. Simply open up the machine settings menu, toggle off the limits temporarily and hit save. Clear the machine from the limit switch by jogging either in the +X or -Y direction. If you're uncertain about which switch has been triggered you can see which alarm has been thrown at the bottom of the screen in FireControl. The triggered switch will be illuminated red in the alarm section at the bottom of the screen.

Once the alarm has been cleared reopen the menu and toggle the limits back on and save. You will notice by default your soft limits are disabled when you turn off the limits. With them disabled your table display will be removed from the visualizer. Soft limits provide a visual display of your position on your table and are helpful when loading a program. They will also prevent your torch from attempting to move outside the travel limits. You will want to re-enable them in the same menu by clicking "enable" from the drop down menu. You cannot toggle on the limits and re-enable soft limits at the same time. The limits must be toggled on and saved before the soft limits can be enabled. It is wise to rehome your machine after performing this procedure to ensure global positional accuracy (Machine Coordinates).
