CROSSFIRE XR **4XB**

CROSSFIRE XR COMPREHENSIVE ADVANCED TECHNICAL SUPPORT AND TROUBLESHOOTING MANUAL REVISION 4

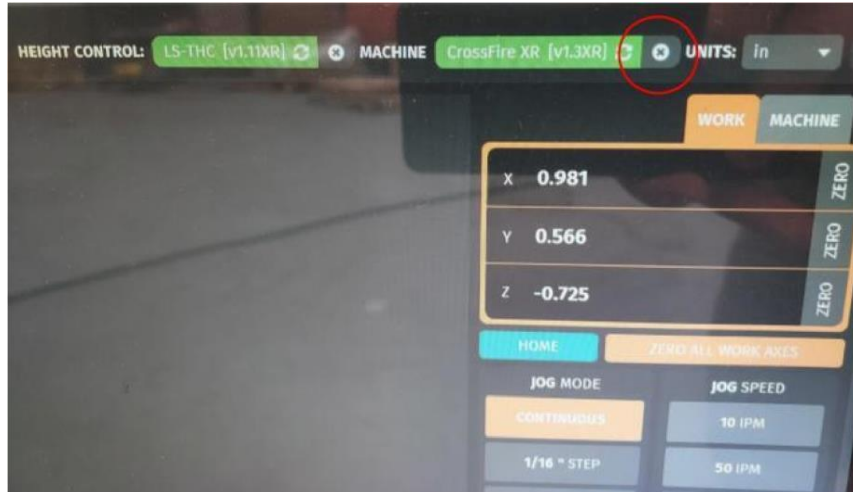
To begin, initiate the homing procedure to square the gantry to the table frame. Next, jog to the affected end of the table. If on the Y-axis, move the entire gantry assembly to the -Y/+Y (Front/Home) position. If on the X, move only the X/Z Carriage subassembly to -X/+X (Y1/Y2 side), whichever side is binding. Disconnect from FC by tapping the button as shown in the image below, then power off the table.

Disconnecting from FireControl before powering down the table will prevent the MC4000 computer from rebooting.

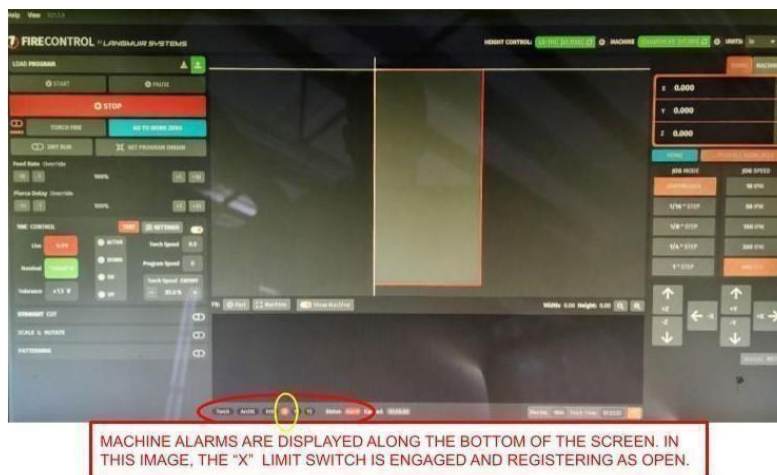
If the gantry fails to home properly one of these scenarios is likely occurring. Use the alarm indicator display at the bottom of the screen to determine which alarms are active:

MACHINE ALARMS ARE DISPLAYED ALONG THE BOTTOM OF THE SCREEN. IN THIS IMAGE, THE "X" LIMIT SWITCH IS ENGAGED AND REGISTERING AS OPEN.

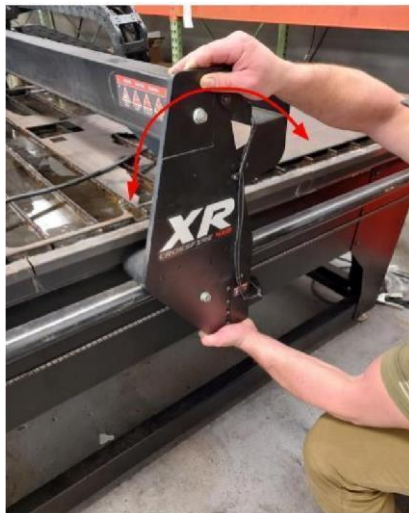
Ensure that the 3 ballnuts are properly lubricated by adding lithium grease to them at the designated fill point. The frequency will vary depending upon use, but every 2-3 months is recommended. Also check the felt washers periodically and saturate with oil and replace them annually or as needed. Additionally, check for rocking in the uprights by grasping the top and base and attempting to rotate about the X axis.
