**CROSSFIRE**  
**4XB XR**

**CROSSFIRE XR COMPREHENSIVE ADVANCED TECHNICAL  
SUPPORT AND TROUBLESHOOTING MANUAL**

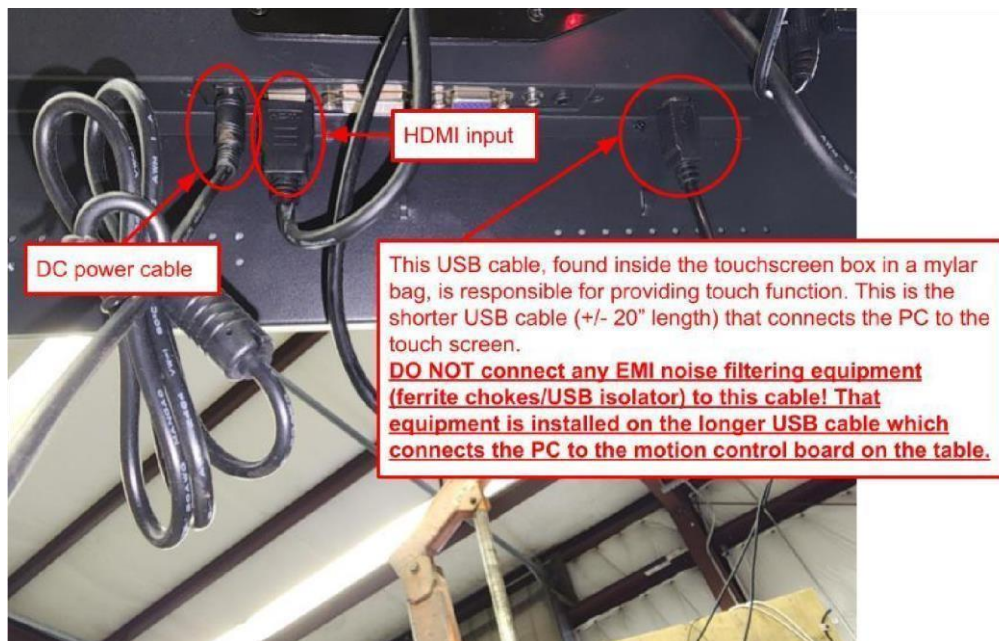
It is likely the short USB cable has not been connected to the touch screen. There should be 3 cables inserted at the bottom of the touch screen: 1. **Power** 2. **HDMI** 3. **12" USB** cable that came inside the white box with the touch screen. Please confirm all 3 cables are connected at the bottom of the touchscreen. If the issue persists, try a different USB slot on the MC4000 then call support between 715-130CST @9362353991.

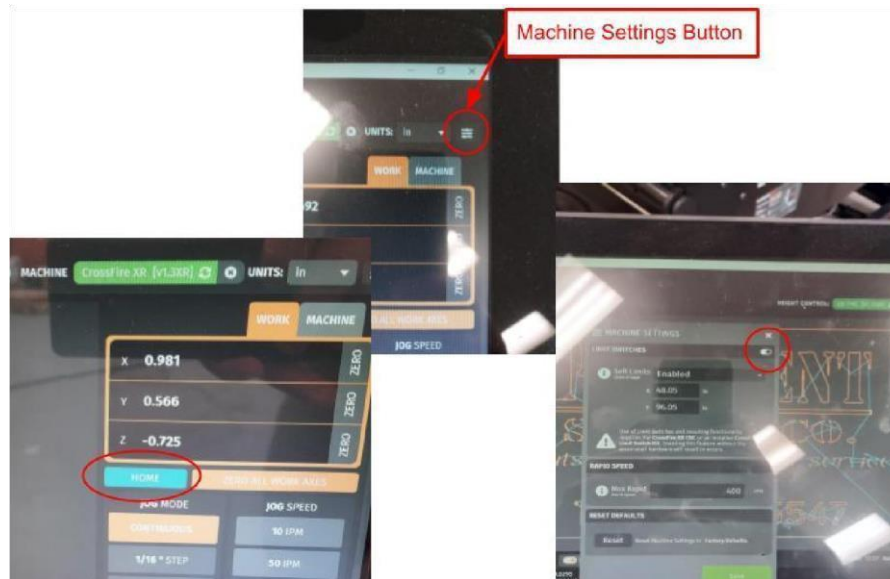
This situation occurs if the limit switches are inadvertently turned off or disabled or simply forgotten to be turned back on. To resolve this issue, open the machine settings menu by clicking the button in the upper right-hand corner of the FC screen, just to the right of the units display. At the very top of that menu, simply toggle on the limit switches and hit save. Then open the menu once more and enable the soft limits from the dropdown menu just below the limit switch toggle button. Then hit save. You cannot complete both processes at once because the limits first have to be turned on and then saved, as the soft limits are a dependent condition of the limit switches being active. That will solve your issue immediately and you will be able to home your table.

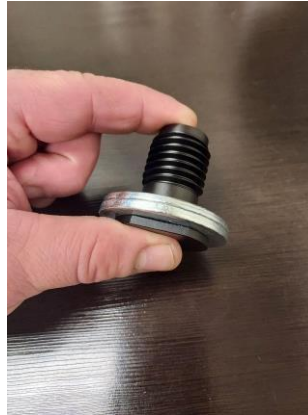
+X, Y2 side) Make sure the gantry/carriage is positioned at least 6" from where you are working to allow for adequate clearance. Insert the hex key into the 1" cap screw securing the ball screw with one hand and grasp the ball screw firmly with the other. Tension the screw a half turn. The ball screw in your hand should be getting tighter. If it is spinning in your hand, there is an issue. Rotation means that the tensioning cap screw has bottomed out and can no longer add any tension to the system. **Under these conditions you can expect there to be binding while jogging above 200IPM.** To remedy this, an additional 1" washer is used to take up enough space so that the threaded cap screw can pull the ball screw tighter.

To do this, loosen the large hex nut securing the rod end bearing mount, then remove the 1" tensioning cap screw. Remove the rod end bearing mount and double up the 1" washer on the outside face. Then carefully reassemble the system and tension and align according to the assembly guide specifications. <https://youtu.be/rcFi07eejpo>

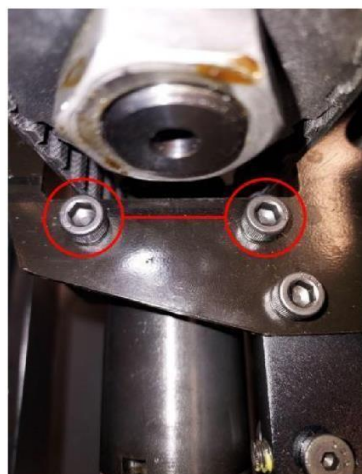
This condition isn't generally the result of issues with the assembly process. In most instances there is minor misalignment in the X-axis ballnut hub that can be resolved very simply. Start by jogging your X/Z carriage to the Y2 side of the table at whatever speed can be managed so it can be easily reached and worked on. Locate the 2 cap screws securing the ballnut hub below.

The screws are located directly underneath the X-motor pulley where the belt goes through the mount. Using a 3/16" Allen key, crack and leave both cap screws 1 full turn loose. Next, jog the carriage towards the Y1 side 18-24". Set your jog speed back to 400 IPM and function test the motion. If the issue is resolved simply hand tighten the cap screws. The hub will be secured by the tension in the ballscrew as well so there is no risk of it coming loose. If the problem persists, proceed to the following step.

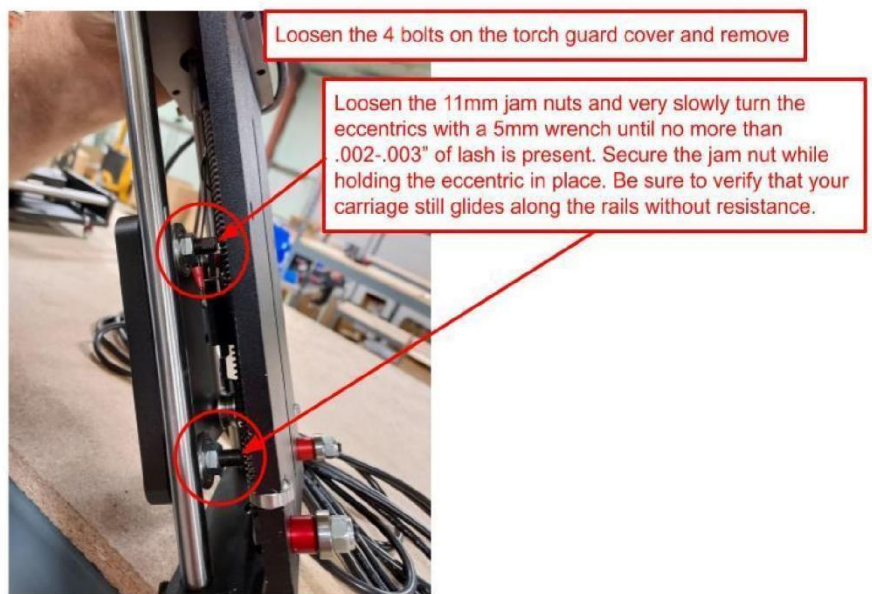
If the lead screw is rotating, check for binding along the vertical guide rails. The slide should move smoothly when jogged in the Z-directions. There should be no binding or sudden drop, caused by the slide failing to move in unison with the lead nut. If you witness this, adjust the V-rollers along the right side of the Z-slide.

Do not overtighten. Gently lift the torch in the slide with your finger and let it drop. The torch and slide must lower along the rails under their own weight, thus ensuring the IHS switch remains in constant contact with the lead nut as it travels downward. If it sticks or drops, adjust the V-rollers as needed.

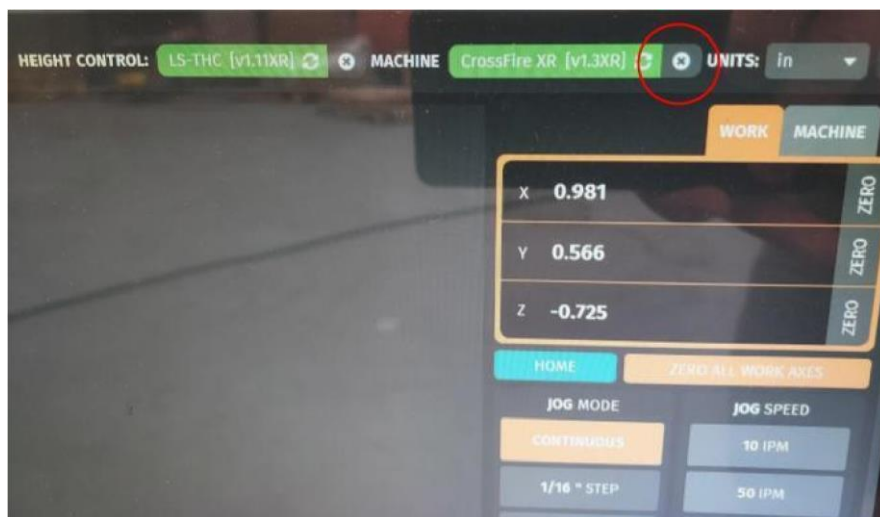
Alignment issues will only be present near the ends of either axis. If you **encounter binding outside of 12" from the travel limits** on either axis alignment is not the issue... Make sure the gantry is located on the side that needs alignment. Please see the alignment video for clarification. <https://youtu.be/rcFi07eejpo> After homing your machine to ensure the gantry is properly squared to the frame, disconnect from FC by clicking here,

then power off the enclosure. Making sure to disconnect before powering off will prevent the computer from rebooting. From the home position, jog in the negative Y-direction approximately 2-3" to allow adequate space to inspect. If there are no issues jogging on the X-axis use this system as your reference. With 2 fingers gently rotate the ballnut and observe the smoothness with which it spins. This is what the other axes should feel like. Inspect the remaining 2 ball nuts for any resistance in the system. If any is present, make sure that your felt washers are not overly compressed and causing friction in the system. If the felts look good and resistance is present there is likely an alignment issue. Simply break loose the hex nut securing the rod end bearing mount and release the tension in the screw. Doing so will allow the system to realign the ball screw. Then simply re-tension and secure the hex nut.

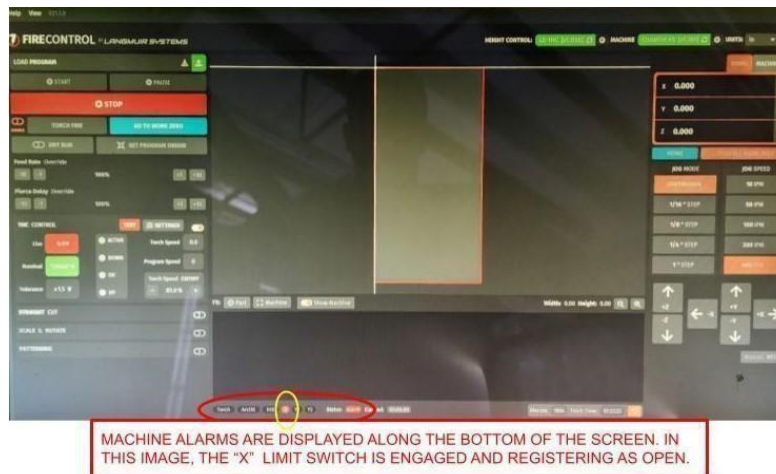
*If the gantry fails to home properly one of these scenarios is likely occurring. Use the alarm indicator display at the bottom of the screen to determine which alarms are active:*

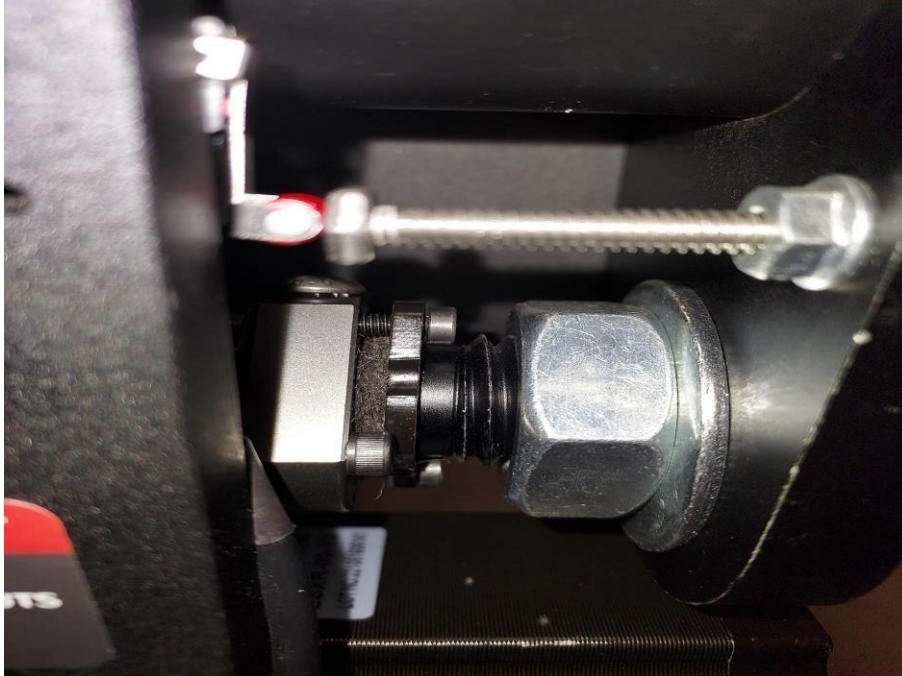
The most likely scenario is that the limit switches are simply not set properly. To ensure that they are, jog the gantry to within a few inches of the home position, then power off the enclosure. Using a 3/8" open-ended wrench, loosen to jam nut securing the limit switch stop and back it out approximately half an inch (away from engaging the limit switch). Then position yourself in the center of the gantry at the rear of the machine and pull evenly across the beam until both ballnuts on the Y-axis are seated against the black aluminum rod end bearing mounts as shown.

Confirm both sides are contacting to ensure the gantry is square to the frame. Next, extend the limit switch stops towards the limit switch. Continue extending until the switch clicks, then continue extending just slightly further until there is approximately 1/32" between the metal arm of the switch and the plastic body of the switch. This will ensure that the limit switch will engage fully before reaching its travel limit while also guaranteeing that there can never be overtravel which could result in the damaging of the switch. Rehome the machine. If trouble persists, continue.

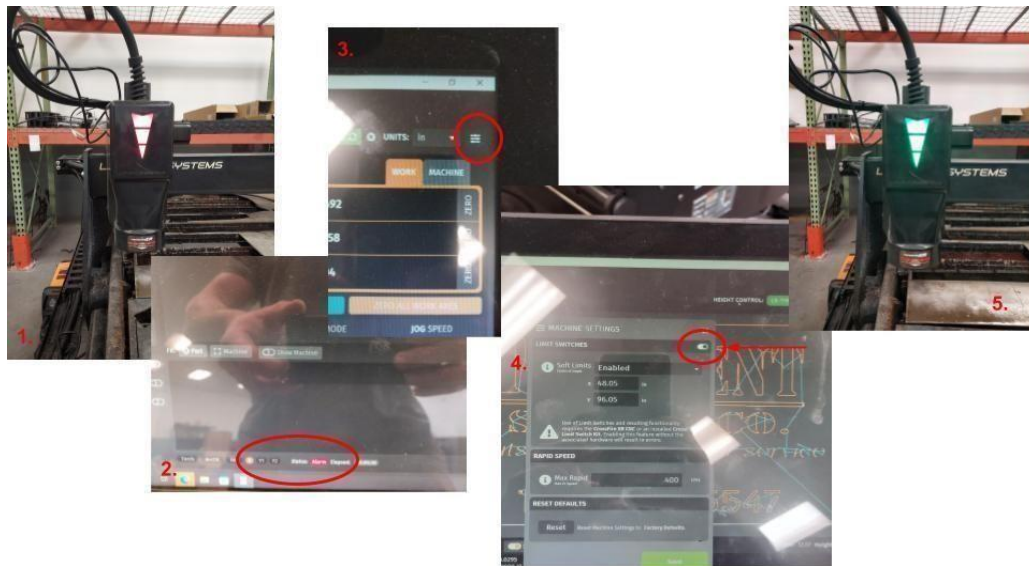
In the event a hard limit is triggered, and the gantry is locked out and immobilized, there is a simple solution that does not require it to be moved off the limit switch manually. Simply open up the machine settings menu, toggle off the limits temporarily and hit save. Clear the machine from the limit switch by jogging either in the +X or -Y direction. If you're uncertain about which switch has been triggered, you can see which alarm has been thrown at the bottom of the screen in FireControl. The triggered switch will be illuminated red in the alarm section at the bottom of the screen.

Once the alarm has been cleared reopen the menu and toggle the limits back on and save. You will notice by default your soft limits are disabled when you turn off the limits. With them disabled your table display will be removed from the visualizer. Soft limits provide a visual display of your position on your table and are helpful when loading a program. They will also prevent your torch from attempting to move outside the travel limits. You will want to re-enable them in the same menu by clicking "enable" from the drop-down menu. **You cannot toggle on the limits and reenable soft limits at the same time. The limits must be toggled on and saved before the soft limits can be enabled.** It is wise to rehome your machine after performing this procedure to ensure global positional accuracy (Machine Coordinates).

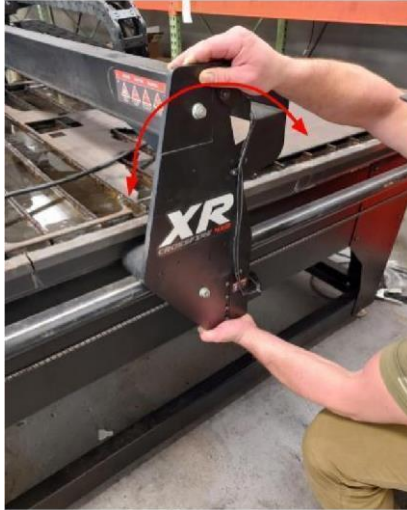
Ensure that the 3 ballnuts are properly lubricated by adding lithium grease to them at the designated fill point. The frequency will vary depending upon use, but every 2-3 months is recommended. Also check the felt washers periodically and saturate with oil and replace them annually or as needed. Additionally, check for rocking in the uprights by grasping the top and base and attempting to rotate about the X axis.

Check each side at the front, center, and rear of the Y - axis rails and adjust the lower V-roller as necessary so that it is in constant contact with the rails. Do not overtighten, simply adjust until the roller contacts the rail. Lastly, check for lash in the X/Z carriage by gently grasping the torch body and rocking along the Y axis.

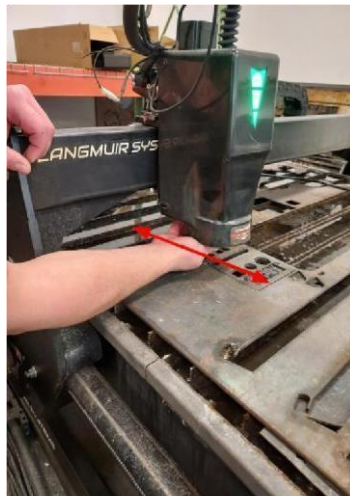
Check at each end of the gantry tube as well as the center and tighten the bearings set while tramming as needed. If there is solid contact between the bearings and the gantry tube and lash is still present, remove the torch guard cover and adjust the V-rollers along the right side of the Z-slide.

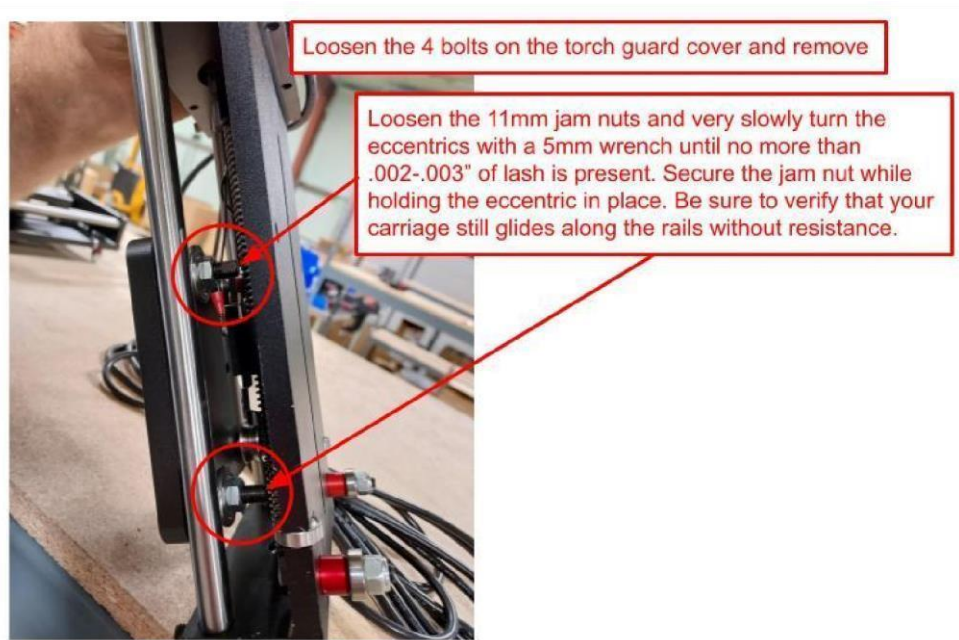
Check for binding along the vertical guide rails. The slide should move smoothly when jogged in both Z-directions. There should be no binding or sudden drop, caused by the slide failing to move in unison with the lead nut. If you witness this, adjust the V-rollers along the right side of the Z-slide.
