# **CROSSFIRE** **4XB XR**

## **CROSSFIRE XR COMPREHENSIVE ADVANCED TECHNICAL SUPPORT AND TROUBLESHOOTING MANUAL REVISION 4**

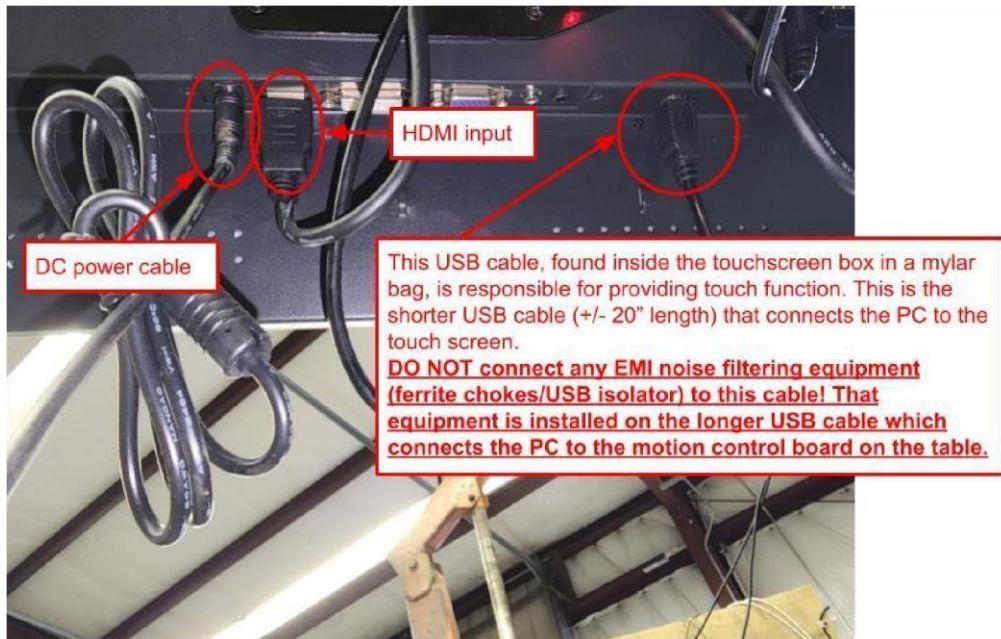
It is likely the short USB cable has not been connected to the touch screen. There should be 3 cables inserted at the bottom of the touch screen: 1. **Power** 2. **HDMI** 3. **12" USB** cable that came inside the white box with the touch screen. Please confirm all 3 cables are connected at the bottom of the touchscreen. If the issue persists, try a different USB slot on the MC4000 then call support between 715-130CST @9362353991.

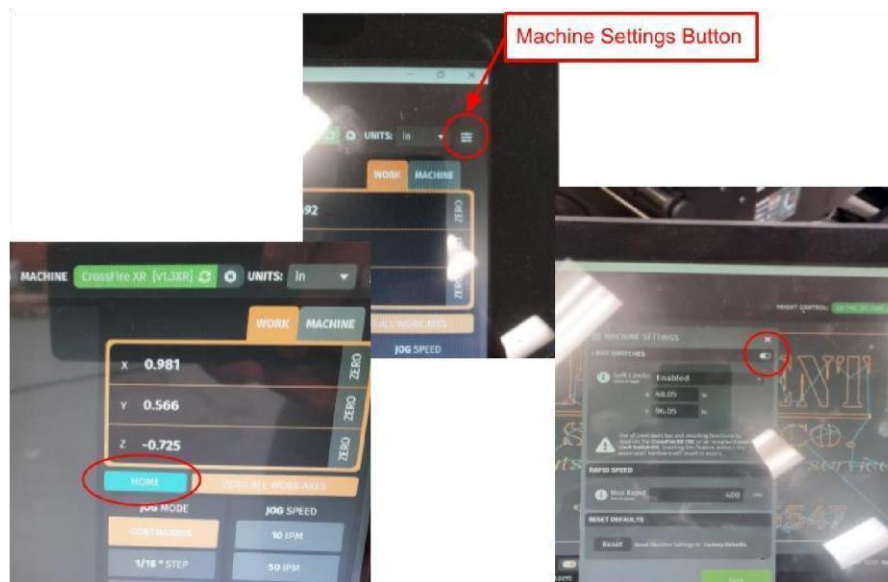
This situation occurs if the limit switches are inadvertently turned off or disabled or simply forgotten to be turned back on. To resolve this issue, open the machine settings menu by clicking the button in the upper right-hand corner of the FC screen, just to the right of the “units” display. At the very top of that menu, simply toggle on the limit switches and hit save. Then open the menu once more and enable the soft limits from the dropdown menu just below the limit switch toggle button. Then hit save. You cannot complete both processes at once because the limits first have to be turned on and then saved, as the soft limits are a dependent condition of the limit switches being active. That will solve your issue immediately and you will be able to home your table.

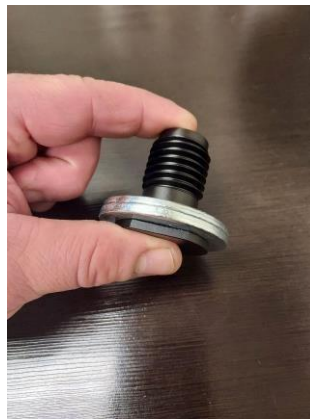
To remedy this, an additional 1" washer is used to take up enough space so that the threaded cap screw can pull the ball screw tighter.

To do this, loosen the large hex nut securing the rod end bearing mount, then remove the 1" tensioning cap screw. Remove the rod end bearing mount and double up the 1" washer on the outside face. Then carefully reassemble the system and tension and align according to the assembly guide specifications. <https://youtu.be/rcFi07eejpo>

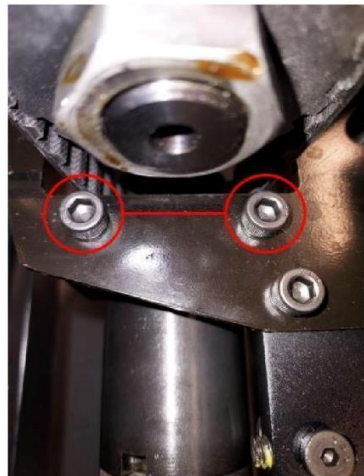
jogging your X/Z carriage to the Y2 side of the table at whatever speed can be managed so it can be easily reached and worked on. Locate the 2 cap screws securing the ballnut hub below.

The screws are located directly underneath the X-motor pulley where the belt goes through the mount. Using a 3/16" Allen key, crack and leave both cap screws 1 full turn loose. Next, jog the carriage towards the Y1 side 18-24". Set your jog speed back to 400 IPM and function test the motion. If the issue is resolved simply hand tighten the cap screws. The hub will be secured by the tension in the ballscrew as well so there is no risk of it coming loose. If the problem persists, proceed to the following step.

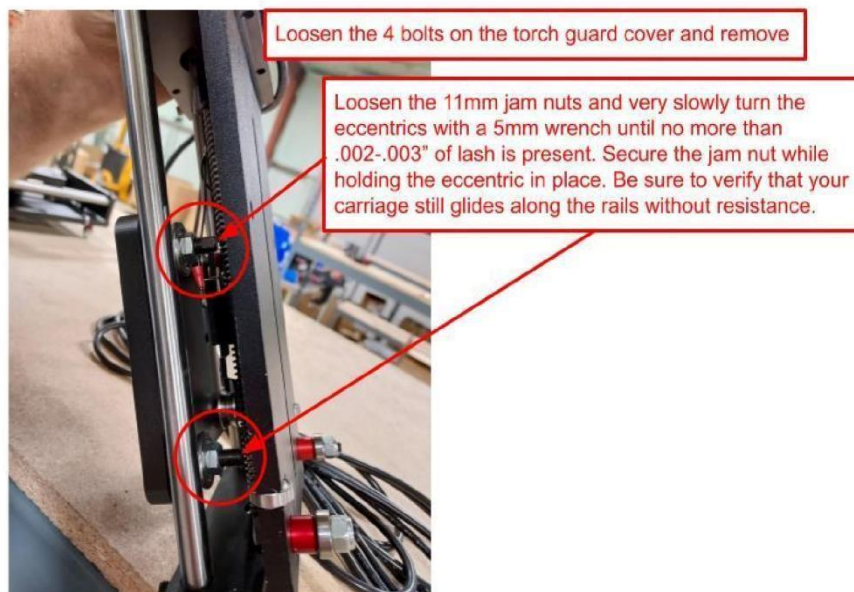
If the lead screw is rotating, check for binding along the vertical guide rails. The slide should move smoothly when jogged in the Z-directions. There should be no binding or sudden drop, caused by the slide failing to move in unison with the lead nut. If you witness this, adjust the V-rollers along the right side of the Z-slide.

Do not overtighten. Gently lift the torch in the slide with your finger and let it drop. The torch and slide must lower along the rails under their own weight, thus ensuring the IHS switch remains in constant contact with the lead nut as it travels downward. If it sticks or drops, adjust the V-rollers as needed.

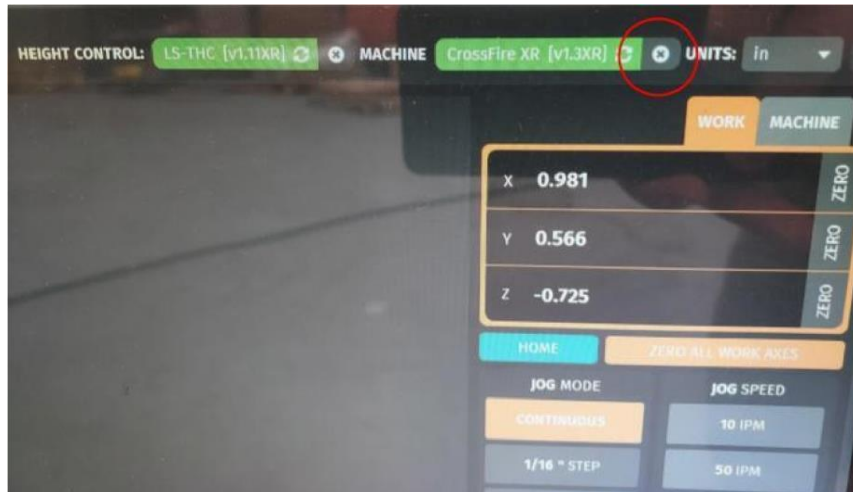
To begin, initiate the homing procedure to square the gantry to the table frame. Next, jog to the affected end of the table. If on the Y-axis, move the entire gantry assembly to the -Y/+Y (Front/Home) position. If on the X, move only the X/Z Carriage subassembly to -X/+X (Y1/Y2 side), whichever side is binding. Disconnect from FC by tapping the button as shown in the image below, then power off the table.

Disconnecting from FireControl before powering down the table will prevent the MC4000 computer from rebooting.

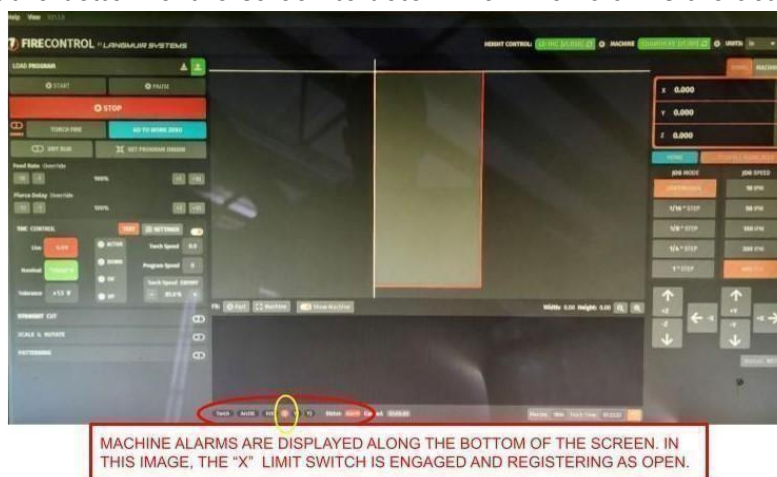
*If the gantry fails to home properly one of these scenarios is likely occurring. Use the alarm indicator display at the bottom of the screen to determine which alarms are active:*

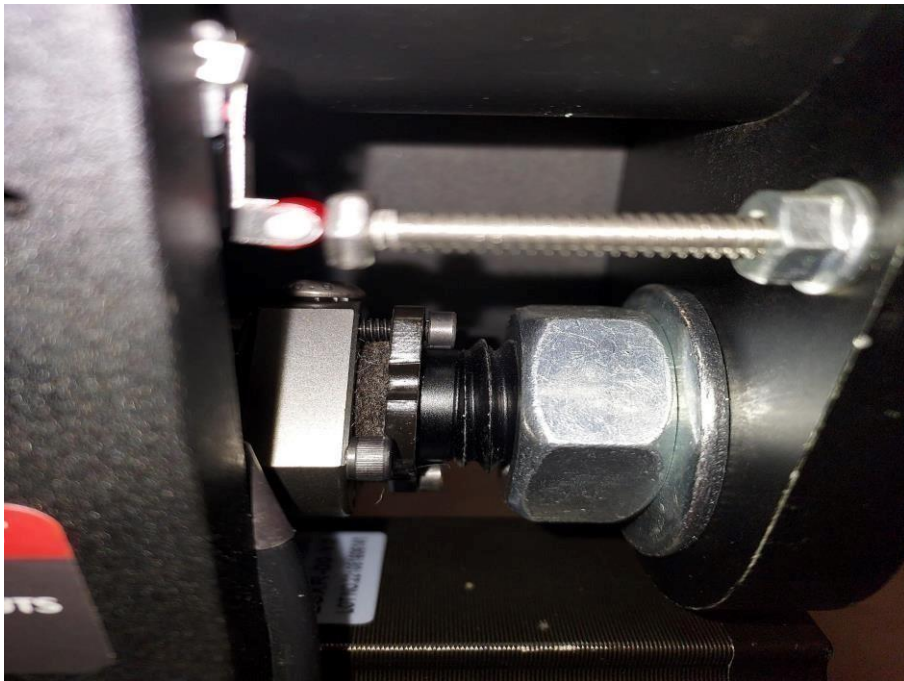
The most likely scenario is that the limit switches are simply not set properly. To ensure that they are, jog the gantry to within a few inches of the home position, then power off the enclosure. Using a  $\frac{3}{8}$ " open-ended wrench, loosen the jam nut securing the limit switch stop and back it out approximately half an inch (away from engaging the limit switch). Then position yourself in the center of the gantry at the rear of the machine and pull evenly across the beam until both ballnuts on the Y-axis are seated against the black aluminum rod end bearing mounts as shown.

Confirm both sides are contacting to ensure the gantry is square to the frame. Next, extend the limit switch stops towards the limit switch. Continue extending until the switch clicks, then continue extending just slightly further until there is approximately  $\frac{1}{32}$ " between the metal arm of the switch and the plastic body of the switch. This will ensure that the limit switch will engage fully before reaching its travel limit while also guaranteeing that there can never be overtravel which could result in the damaging of the switch. Rehome the machine. If trouble persists, continue.

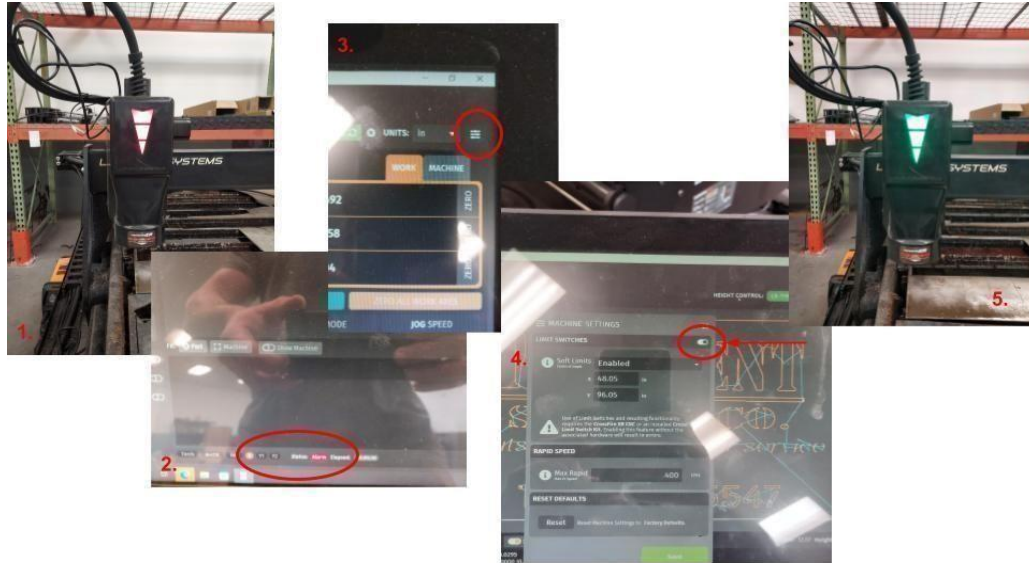
In the event a hard limit is triggered, and the gantry is locked out and immobilized, there is a simple solution that does not require it to be moved off the limit switch manually. Simply open up the machine settings menu, toggle off the limits temporarily and hit save. Clear the machine from the limit switch by jogging either in the +X or -Y direction. If you're uncertain about which switch has been triggered, you can see which alarm has been thrown at the bottom of the screen in FireControl. The triggered switch will be illuminated red in the alarm section at the bottom of the screen.

Once the alarm has been cleared reopen the menu and toggle the limits back on and save. You will notice by default your soft limits are disabled when you turn off the limits. With them disabled your table display will be removed from the visualizer. Soft limits provide a visual display of your position on your table and are helpful when loading a program. They will also prevent your torch from attempting to move outside the travel limits. You will want to re-enable them in the same menu by clicking “enable” from the drop-down menu. **You cannot toggle on the limits and re enable soft limits at the same time. The limits must be toggled on and saved before the soft limits can be enabled.** It is wise to rehome your machine after performing this procedure to ensure global positional accuracy (Machine Coordinates).

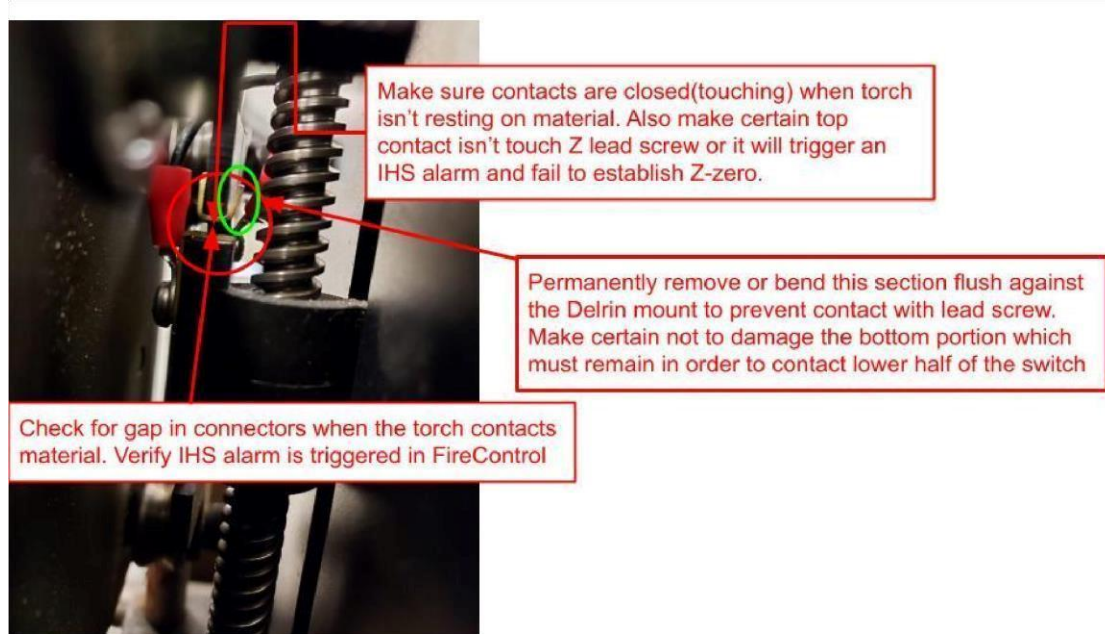
If FireControl is unable to establish Z-zero due to an IHS fail it is likely that the IHS switch has been compromised and needs corrective action. This can happen if the Z axis is accidentally maxed out in the +Z direction. When this occurs the upper IHS contact can snag between the motor shaft coupler that connects the Z lead screw and is often bent towards the lead screw. If the switch contacts the screw, it will ground and register in FC as an open circuit, preventing FireControl from establishing Z-zero. It can also cause the THC to read a non-zero voltage while at rest or trigger a misfire warning alarm in FC due to a perceived voltage spike. Because of how voltage is interpreted by FireControl, even a minute extraneous voltage input from the 5V switch leaching into the frame will cause a massive spike.

To permanently correct this, use tin snips or a sharp pair of metal-cutting scissors to nip off the tab that is bent towards the screw. Make certain not to damage the bottom portion of the brass tab which needs to remain in contact with the lower half of the switch to function properly. If you are unable to remove the tab, you can use two flat-blade screwdrivers to bend the tab back flush against the black Delrin mount it is attached to, parallel with the torch slide and away from the lead screw.

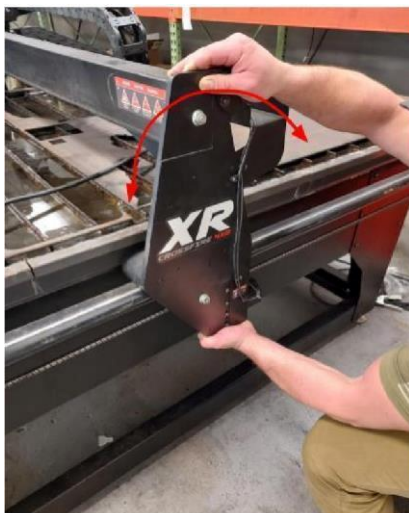
Ensure that the 3 ballnuts are properly lubricated by adding lithium grease to them at the designated fill point. The frequency will vary depending upon use, but every 2-3 months is recommended. Also check the felt washers periodically and saturate with oil and replace them annually or as needed. Additionally, check for rocking in the uprights by grasping the top and base and attempting to rotate about the X axis.

Check each side at the front, center, and rear of the Y - axis rails and adjust the lower V-roller as necessary so that it is in constant contact with the rails. Do not overtighten, simply adjust until the roller contacts the rail. Lastly, check for lash in the X/Z carriage by gently grasping the torch body and rocking along the Y axis.

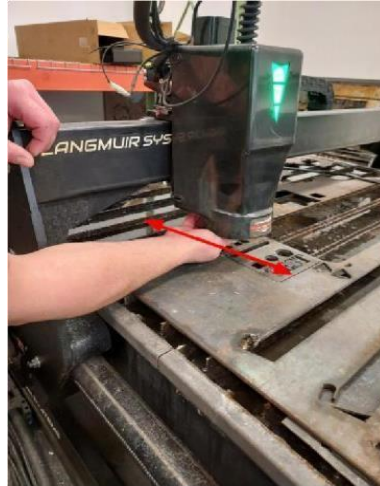
Check at each end of the gantry tube as well as the center and tighten the bearings set while tramming as needed. If there is solid contact between the bearings and the gantry tube and lash is still present, remove the torch guard cover and adjust the V-rollers along the right side of the Z-slide.

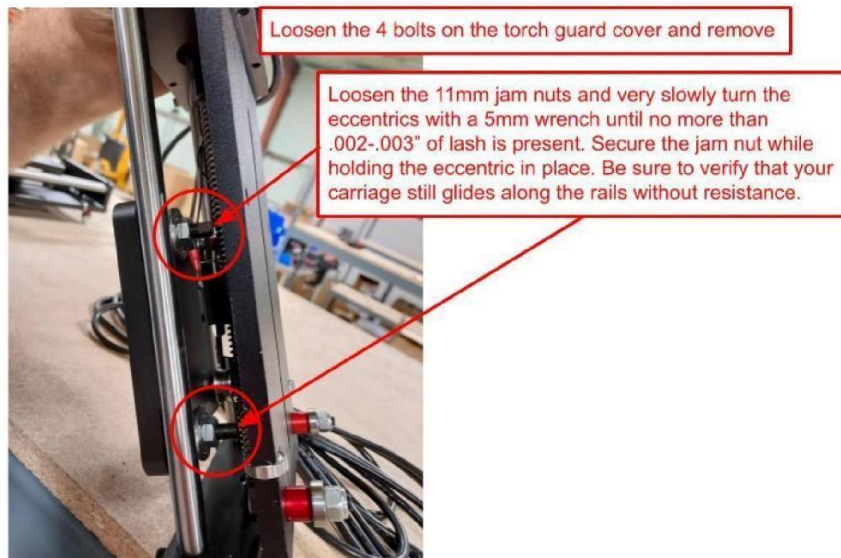
Check for binding along the vertical guide rails. The slide should move smoothly when jogged in both Z-directions. There should be no binding or sudden drop, caused by the slide failing to move in unison with the lead nut. If you witness this, adjust the V-rollers along the right side of the Z-slide.
