Backgauge Troubleshooting

TITAN 25T LANGMUIR SYSTEMS

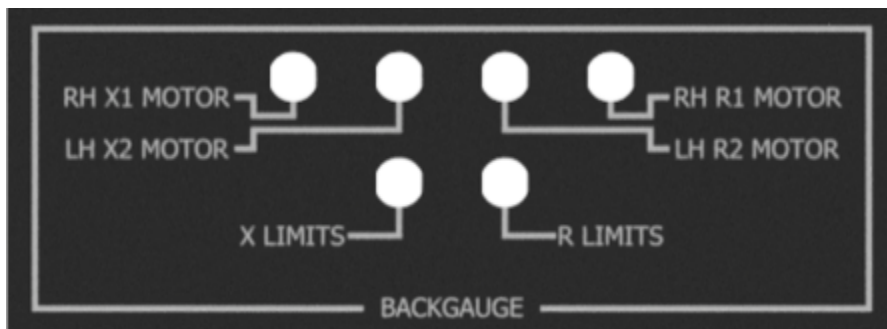
4. Unplug the R1 and R2 motor cables in the back of the machine and swap the positions they are plugged into. R1 in the R2 slot and vice versa.
